**MARINE ACCIDENT
INVESTIGATION BRANCH**

SAFETY DIGEST

**Lessons from Marine
Accident Reports
1/2018**

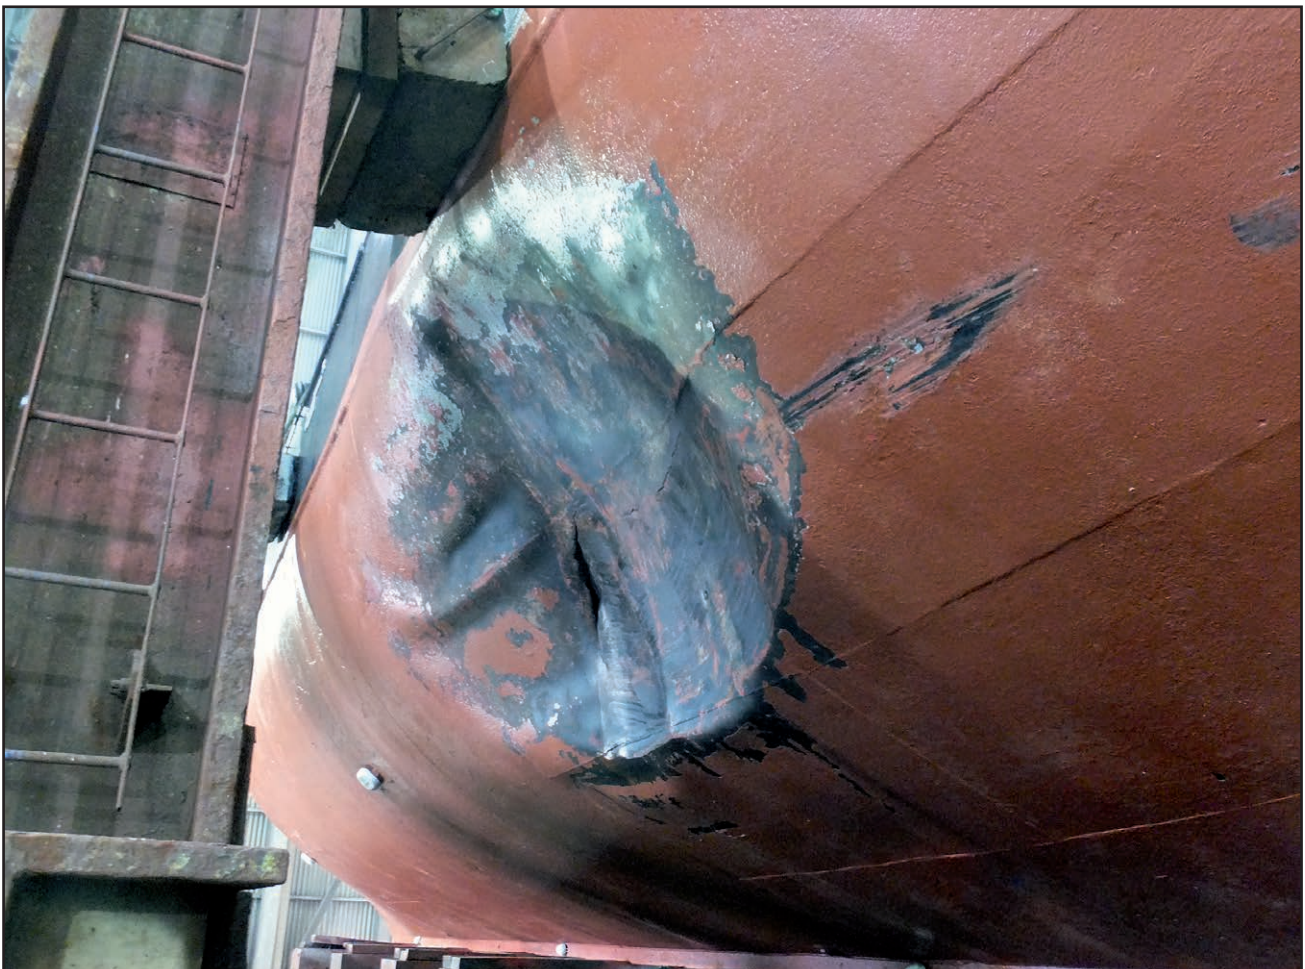
The bunker barge suffered a large indentation below the waterline where it was struck by the cargo ship's bulbous bow (see figure). There was also significant flooding of the vessel, the main engine seized and there was some pollution from leaking fuel cargo.

Figure: Indentation in the bunker barge's hull caused by the cargo ship's bulbous bow

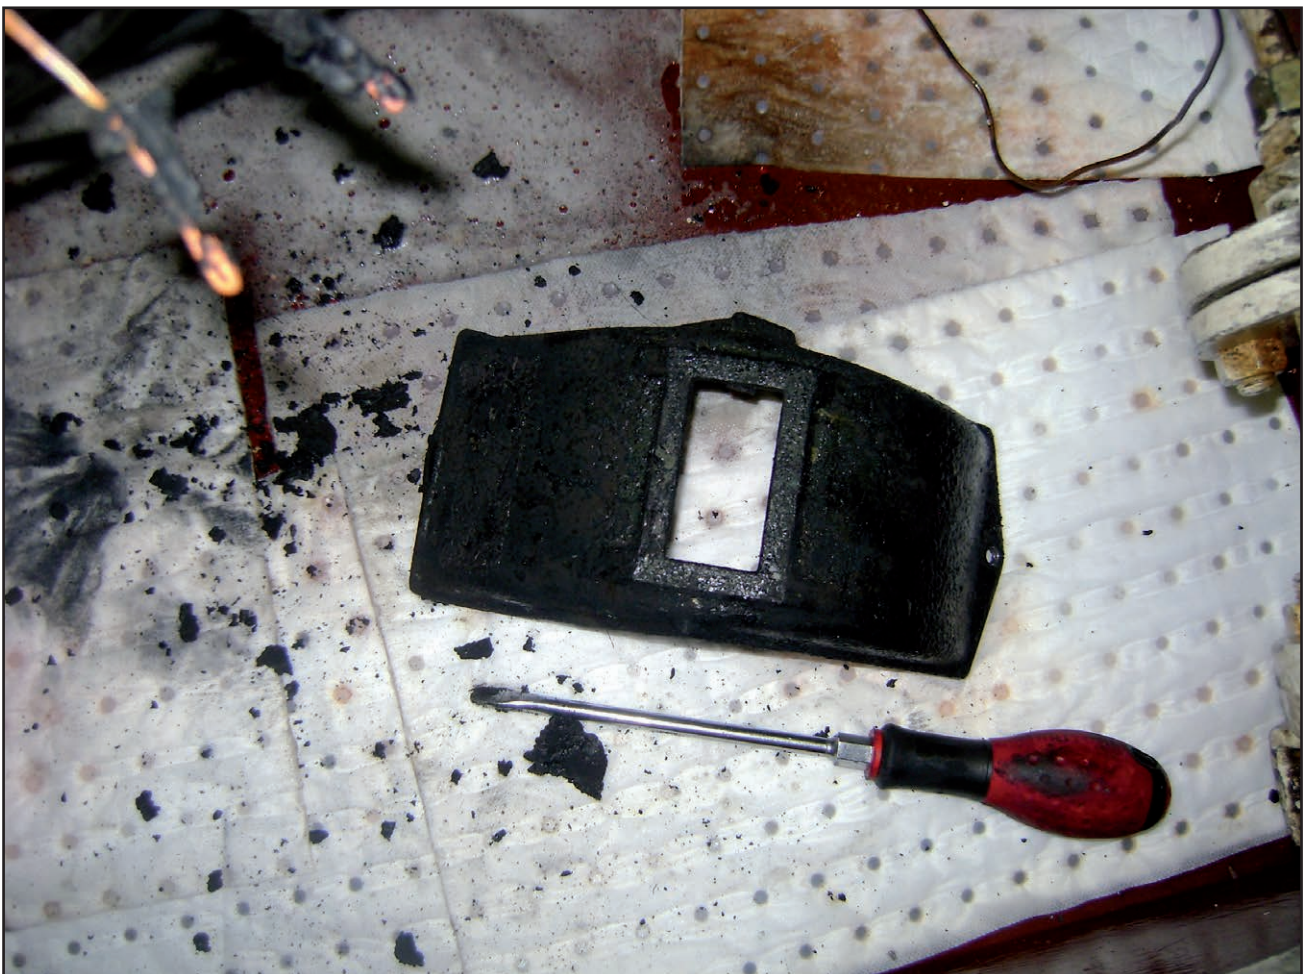
Shortly after the boiler began operating, the engine room fire alarm activated, indicating a fire in the vicinity of the auxiliary boiler. The vessel's engineers were mustered and sent to the engine room to investigate. When they approached the auxiliary boiler they saw flames inside the burner casing and smoke entering the engine room through the burner unit's

Figure 1: The burner unit's melted sight glass

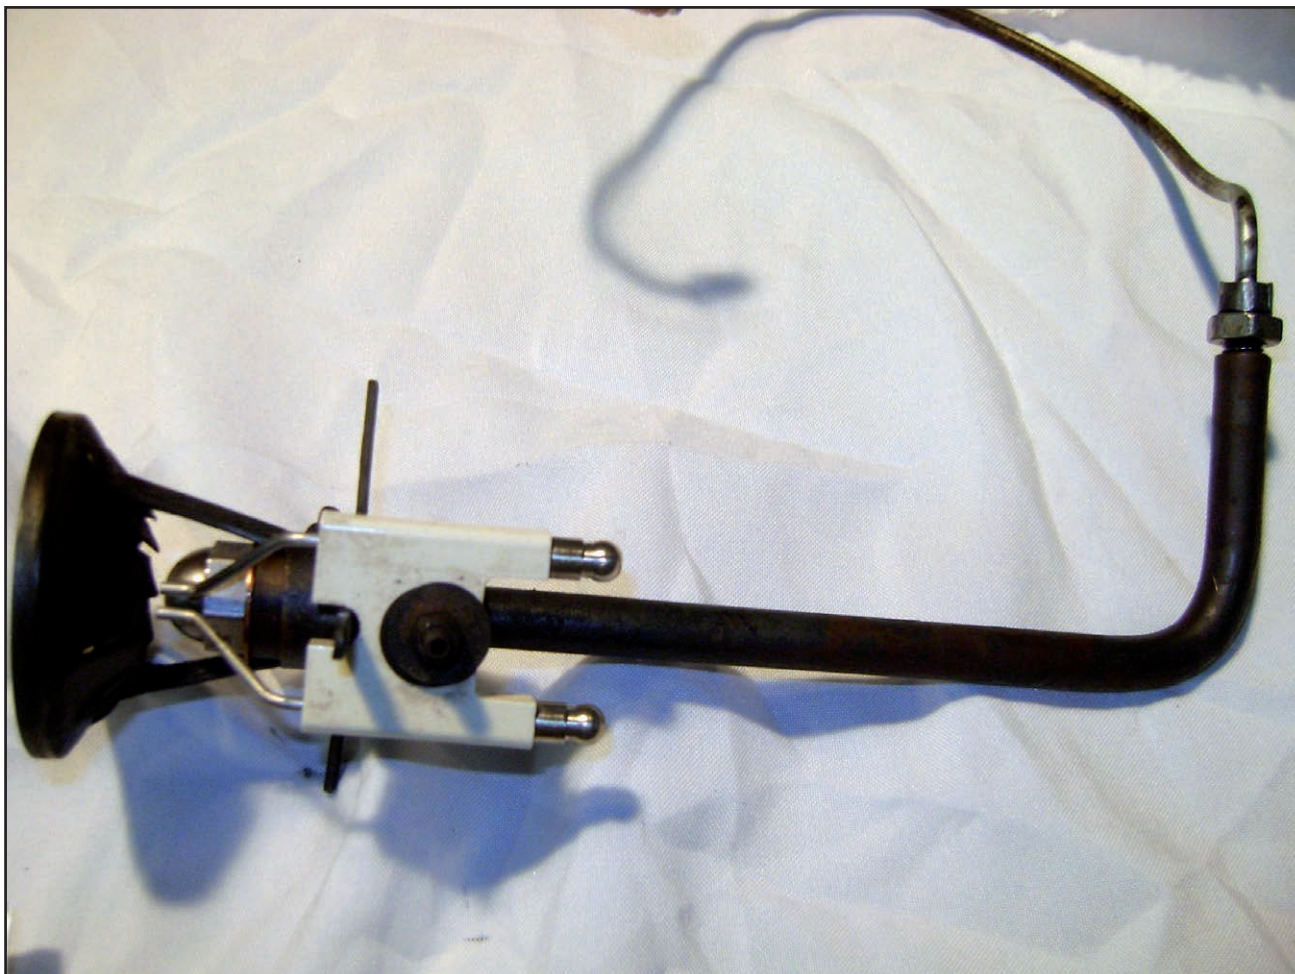
When the boiler was examined, the engineers found that the internal fuel supply pipe to the burner nozzle (Figure 2) was leaking at a compression fitting. When the pipe was removed, one of its compression fittings was found to be worn and damaged to the point it could no longer provide a seal against the fuel pressure. Fortunately, in this case, the consequences of the fire were not serious. However, boiler explosions, including those resulting in fatalities, have occurred when there has been fuel leakage into a boiler furnace.

Figure 2: The leaking internal fuel supply pipe to the burner nozzle

1. Regular inspections of the boiler burner unit required the routine removal and refitting of the fuel supply pipe. This provided the opportunity for the condition of the pipe fittings to be assessed. However, as in this case, it also introduced the risk of damaging the seals. All work carried out to the fuel pipework and compression fittings should be closely inspected before being fitted; a zero tolerance on wear and damage will help minimize the risk of fuel leakage and the subsequent introduction of a fire danger.

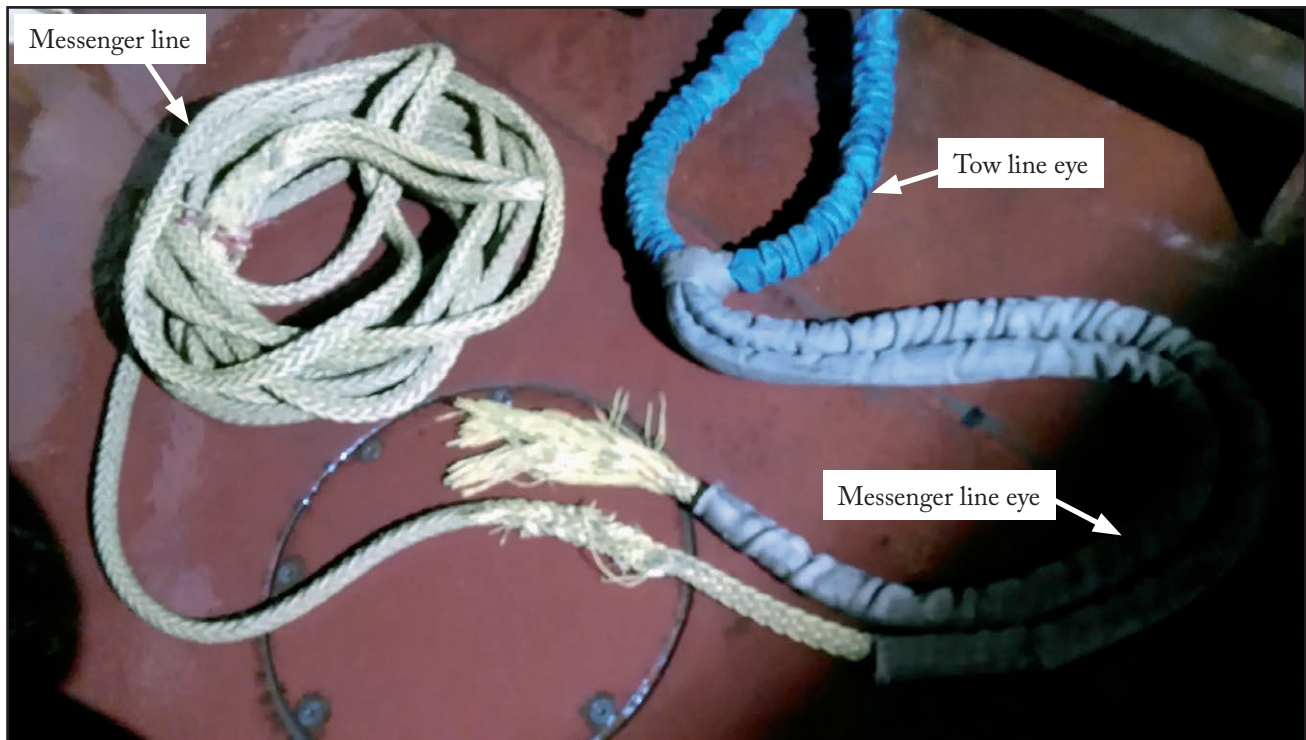
The tug recovered the parted line back on board. The messenger rope's eye, which was connected to the eye of the main towline, had parted (Figure 2). The crew on the bulk carrier's aft mooring deck had mistakenly placed the eye of the messenger rope rather than that of the towline over a bitt to make the towline fast.

Figure 2: Parted messenger line eye

1. The messenger line's eye was similar in size to that of the towline and large enough to be readily placed over the aft deck mooring bitt. Although the cordage used for the messenger was smaller in diameter than the towline, the sleeves used on the eyes of both ropes were similar in appearance and led to the crew mistakenly placing the wrong eye over the bitts. The use of different coloured sleeves might have prevented the confusion.
2. Towing operations in harbour are routine tasks that are potentially hazardous or, as in this case, can lead to avoidable accidents if crew members fail to keep their wits about them at all times.

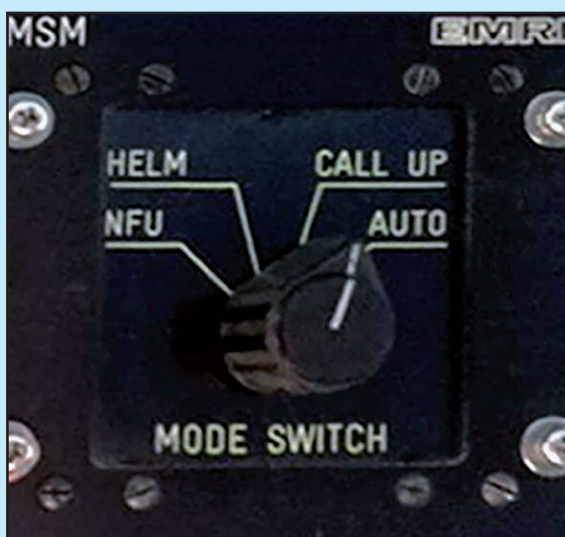
1. The steering mode selector switch at the centreline helm console had four settings: 'auto', 'helm', 'call up' and 'nfu'¹ (Figure 1). The normal procedure when changing from autopilot to manual steering was to change the selector switch setting from 'auto' to 'call up'. The 'call up' setting allowed the vessel to be steered manually from the centreline helm console, and when a selector button was pressed on the bridge wing, to then be steered from the bridge wing. On this occasion, the selector switch was inadvertently changed to the 'helm' setting, which allowed manual steering from the centreline helm console only.

Figure 1: Steering mode selector switch

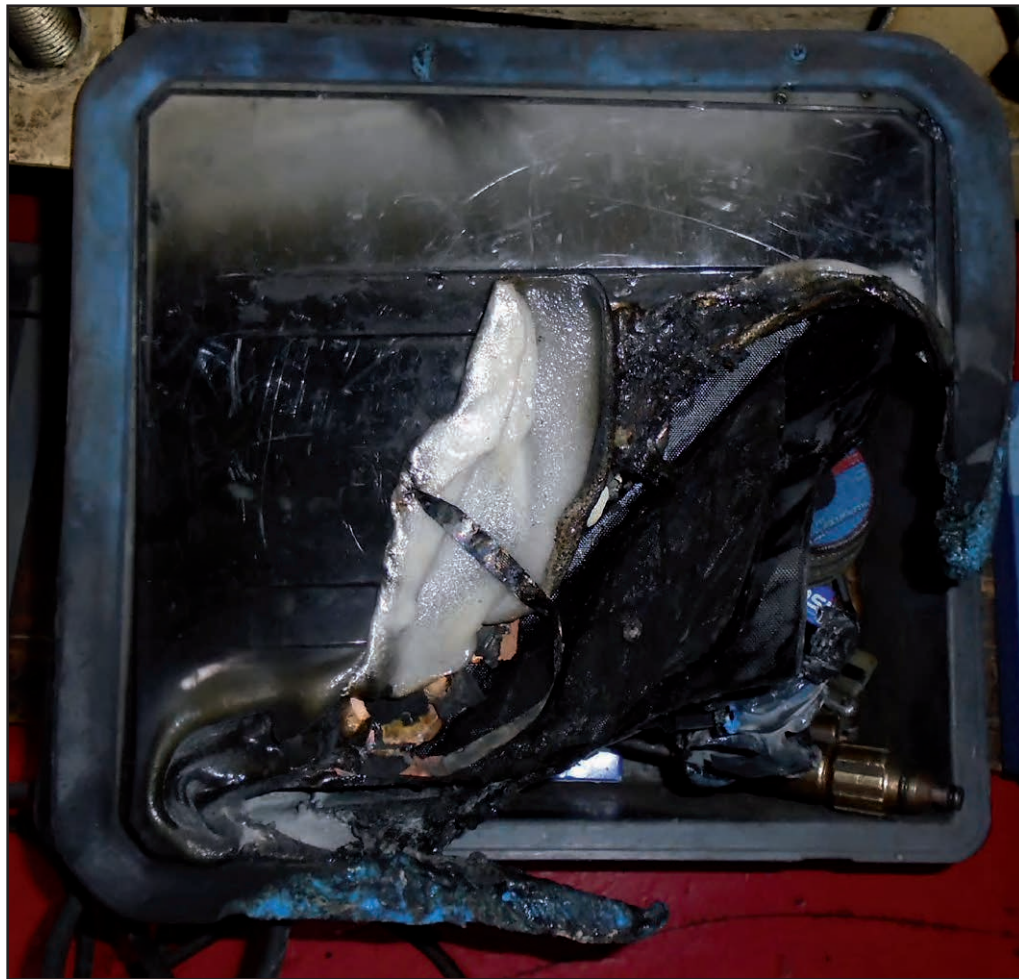
Investigations revealed that a portable light unit, used earlier in the day, had been left at the bottom of the boiler and that sparks from the cutting process had caused the unit to ignite. The contractors had reacted quickly and had extinguished the fire using fire-fighting equipment that had been located close to the work-site as part of the PTW requirements.

Figure 2: Damaged light unit

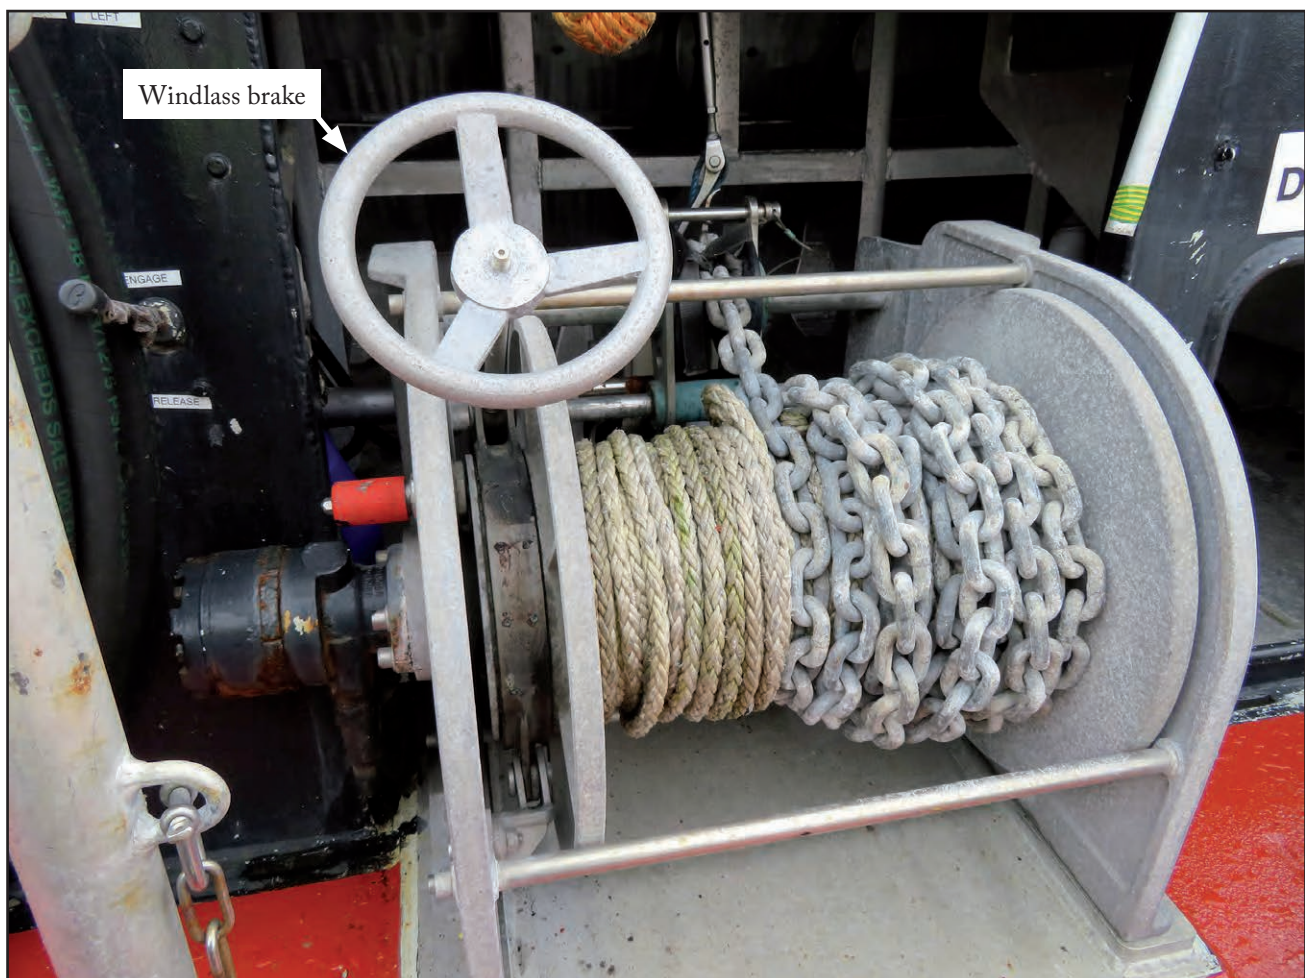
About 4 hours later, the low fuel pressure alarm on the starboard engine sounded. In response, the master ordered his crewman to prepare the anchor for letting go. As the crewman arrived on the forecastle, the engine stopped and the order was given to let go the anchor. However, when the crewman released the windlass the anchor failed to 'free fall' (see figure).

Figure: The windlass and brake

2. One of the most significant safety issues identified in this incident was the crew's inability to anchor the vessel in an emergency. The post-incident inspection by the anchor windlass manufacturer revealed that the aluminium windlass bearings were clogged with dirt and, although it could still be operated under power, the debris prevented the anchor being 'let go' in the 'free fall' mode. A subsequent fleet-wide inspection revealed a similar defect in other vessels. This issue had not been previously exposed by either class or regulatory inspection. Following its investigations, the vessel operator introduced a planned maintenance routine that required weekly fresh water wash down of the windlass, anchor 'free fall' mode tests and an annual overhaul.

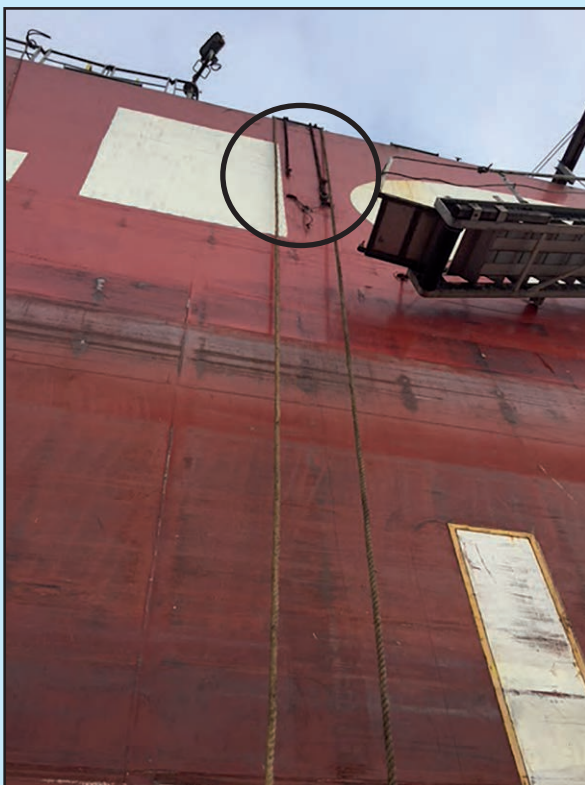
The pilot ladder that had failed was only 15 months old. An internal investigation by the company found that the pilot ladder side ropes had failed through exposure to salt deposits and sunlight (Figure 2), which the ship's crew had not identified.

Figure 2: Ladder rigged position, showing broken section

In this case, the relatively new pilot ladder had not been properly maintained and stowed, and deterioration to the pilot ladder side ropes had not been identified. Do not store ladders on an open deck where the ropes are exposed to contaminants or elements that can degrade the ropes (Figure 3). After use, ladders should ideally be hung up clear of the deck

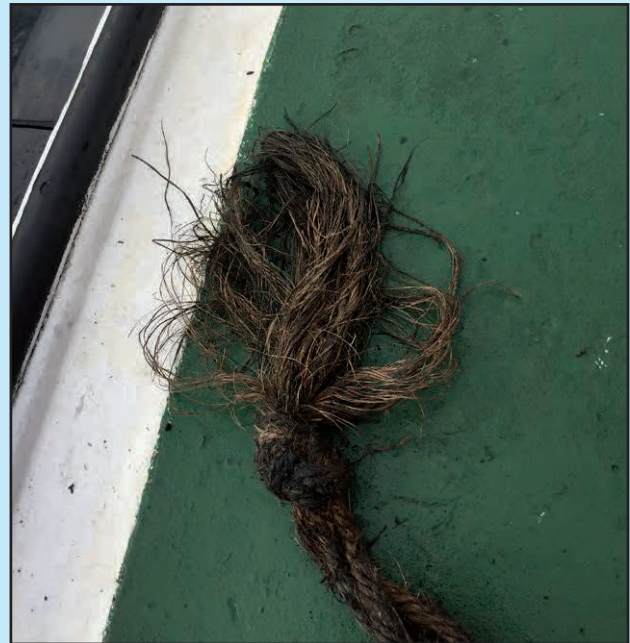
Figure 3: Ladder side rope showing contamination

and stored wherever possible in a clean, dry environment. They must also be protected from oil, chemicals, paint, or any other source of contamination that could affect their strength.

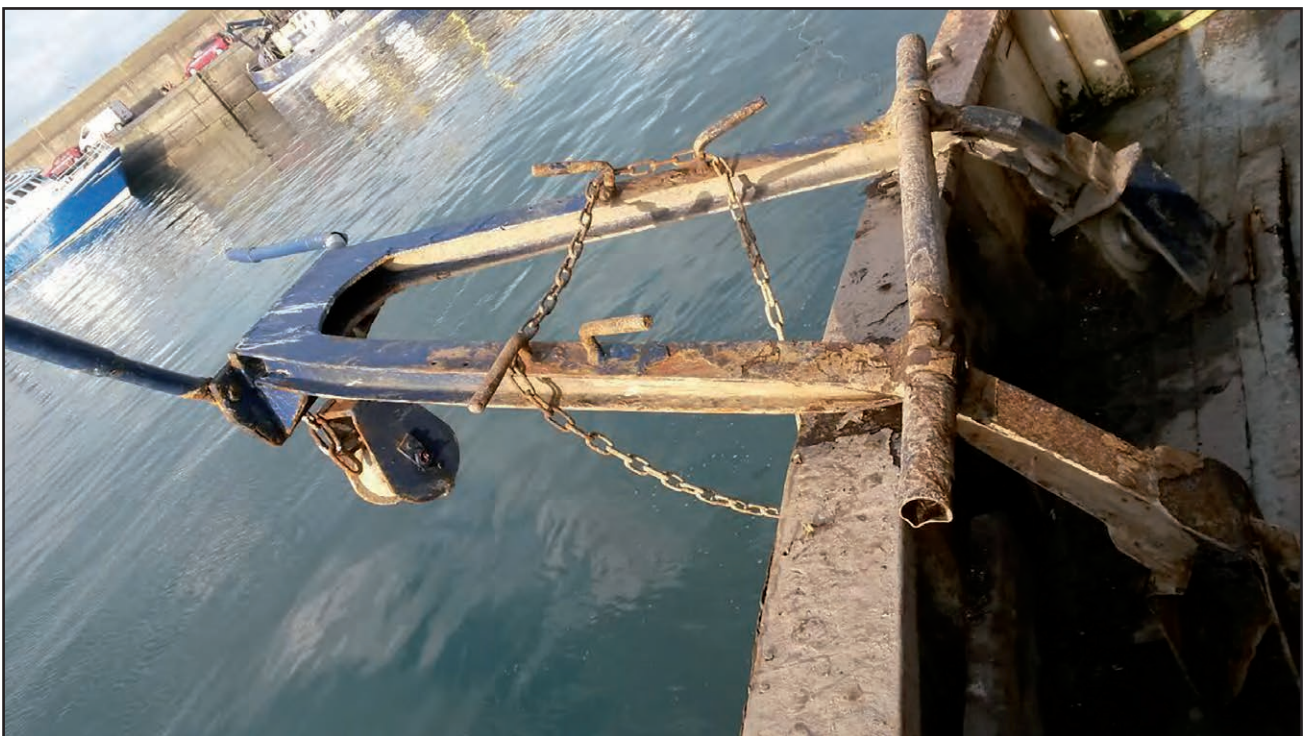
Figure: Damage to the prawn trawler's port gallows (looking from aft to forward)

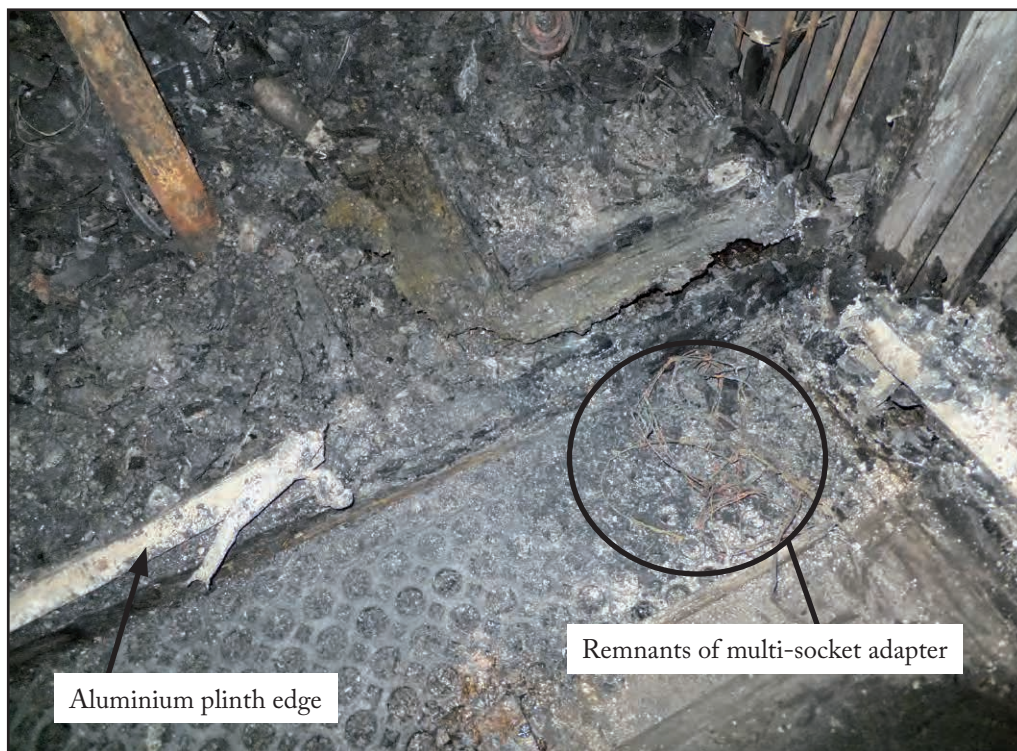
Figure 2: Remnants of multi-socket adapter

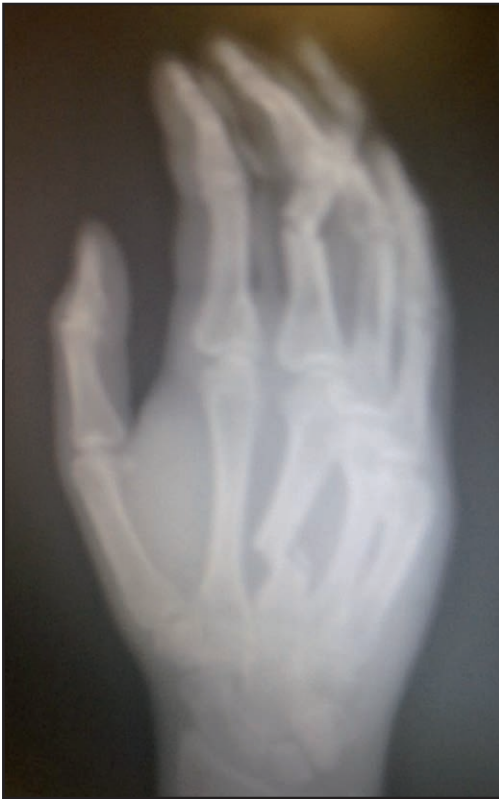
Figure 2: X-ray showing multiple fractures

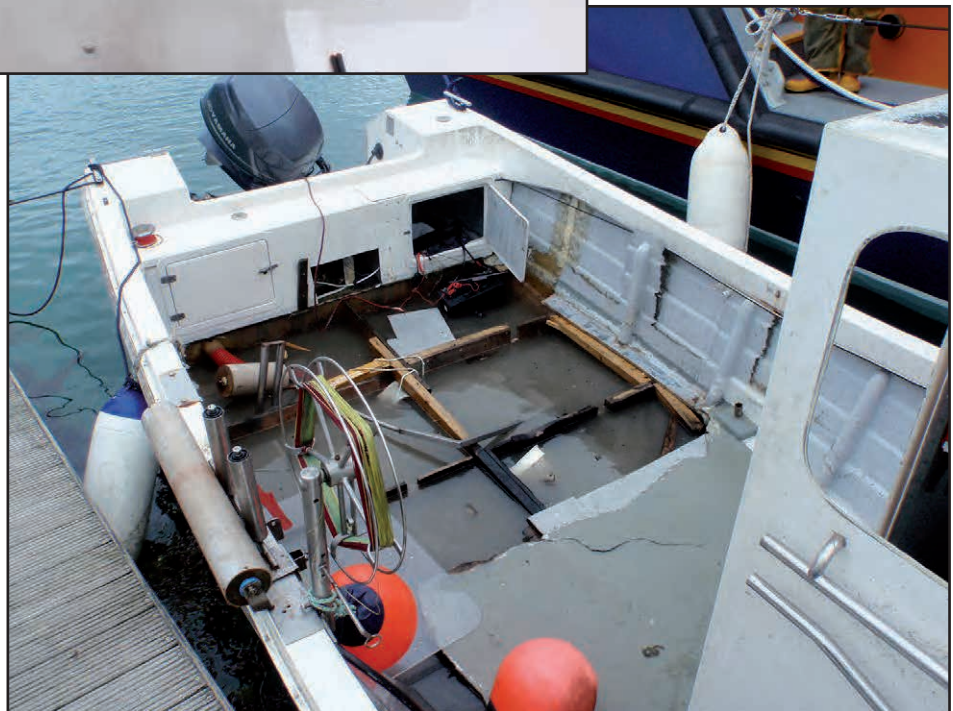
It is likely that a leak between the flush deck fitting and the fuel tank allowed petrol to leak into the vessel's bilge when the tank was filled the evening before departure (Figure 2).

Figure 2: Layout of the vessel

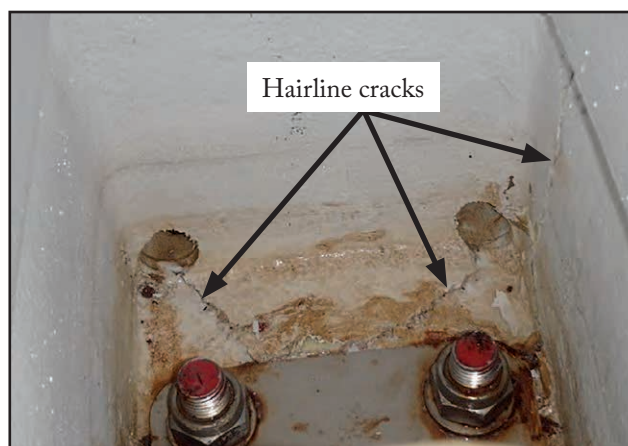
Figure 1: Hairline cracks around the yacht's keel bolts

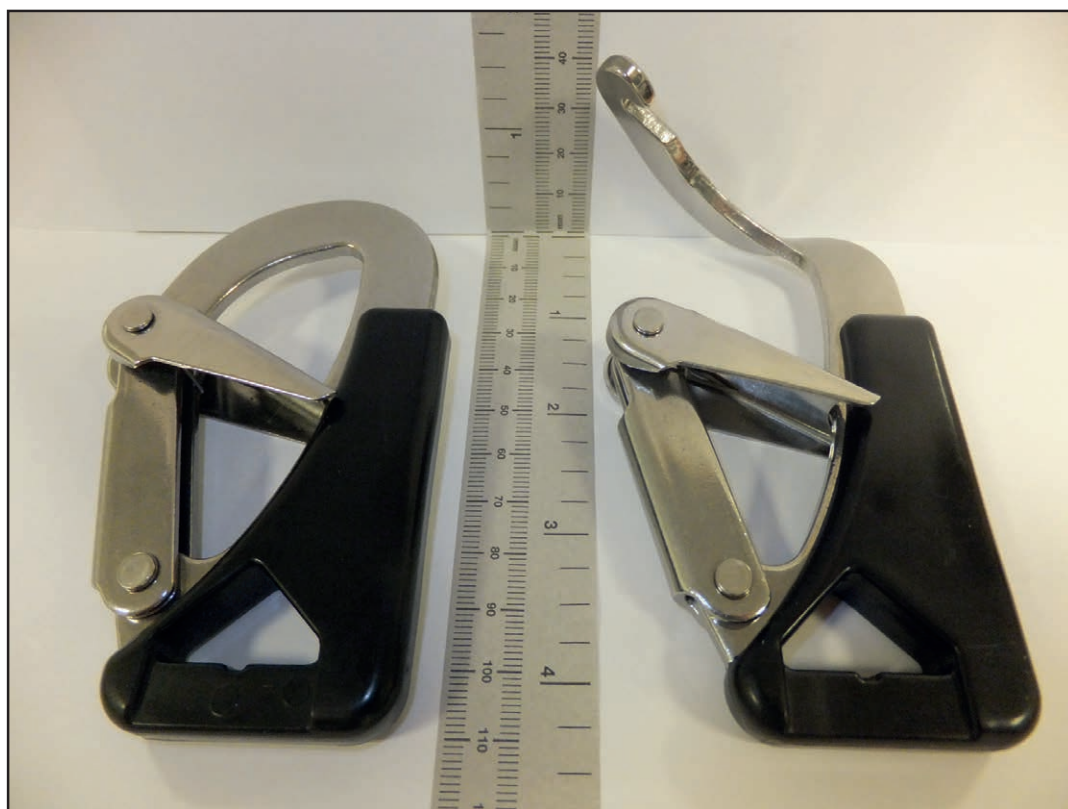
Figure 2: Example of a tether hook and a tether hook after lateral loading
