## ENDURES - RPT19027

Field efficacy test of environmentally friendly antifouling products for pleasure boats in The Netherlands.

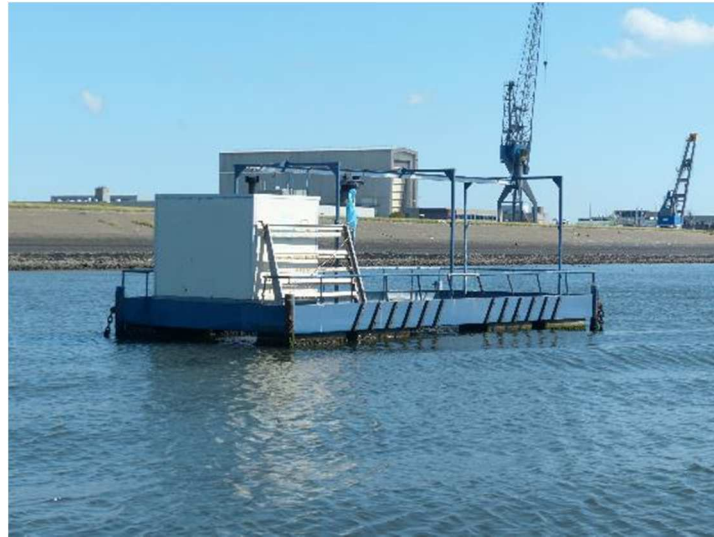
The static exposure test was carried out at the raft of Endures in the harbour of Den Helder (see Figure 1). In this harbour natural tidal currents occur that vary between 0 and 2 knots. Distance from the shore is less than 50 m and water depth at the position of the raft is at least 8 m.

Figure 1. Raft exposure facility of Endures in the harbour of Den Helder, The Netherlands

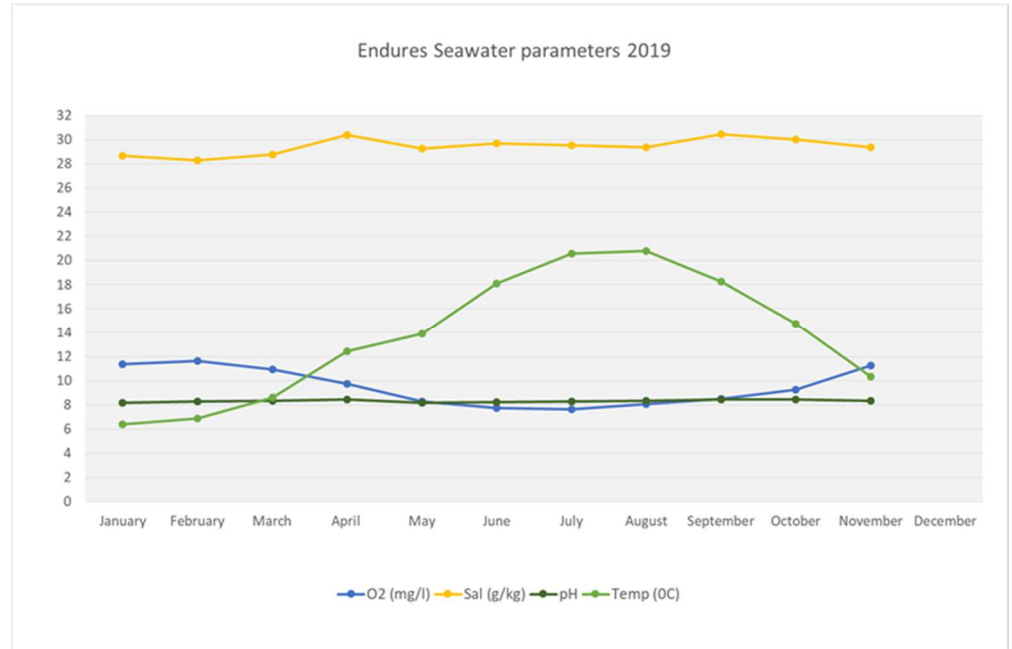
Figure 3. Main physico-chemical parameters of seawater in the harbour of Den Helder in 2019.

The water conditions in the harbour vary with the season. Main physico-chemical parameters of the seawater are continuously monitored. Figure 3 gives an overview of measurement results (monthly averages) on pH, oxygen content (mg/L), temperature and salinity (g/kg) during the period January - November 2019.

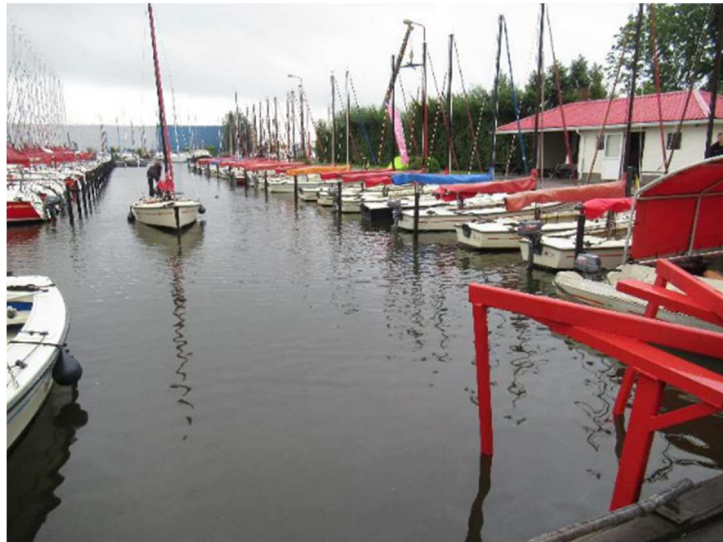
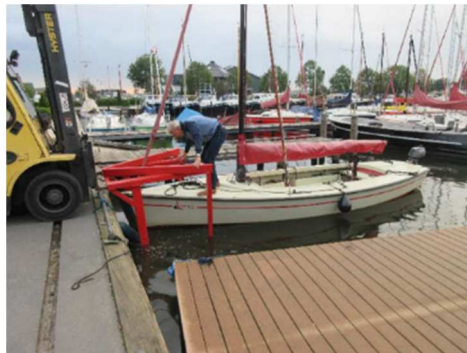
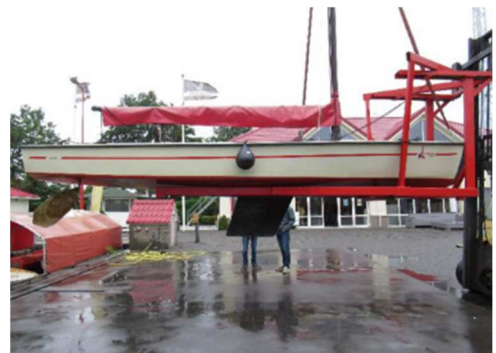
Ottenhome had a very efficient way of boat lifting for the hull inspections, see the pictures in Figure 4. In this way three inspections were carried out on the following dates: July 4, August 15 and September 24 in 2019.

Figure 4. Illustration of boat lifting process at fresh water location Ottenhome in Heeg.

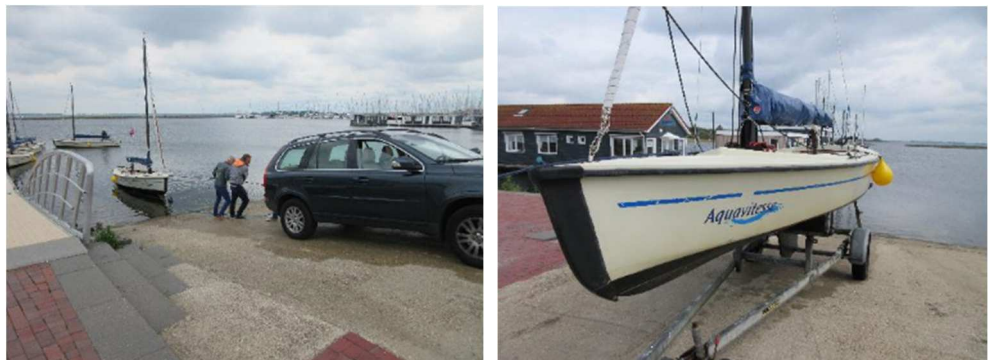
Boat lifting procedure at the company Aquavitesse was quite different from the one used in Heeg as illustrated in Figure 5 and Figure 6. In Bruinisse five inspections were carried out on the following dates: June 13, July 12, August 23, September 19 and October 25 in 2019.

Figure 5. Boat lifting procedure for small boats ("Valken") at Aquavitesse in Bruinisse.

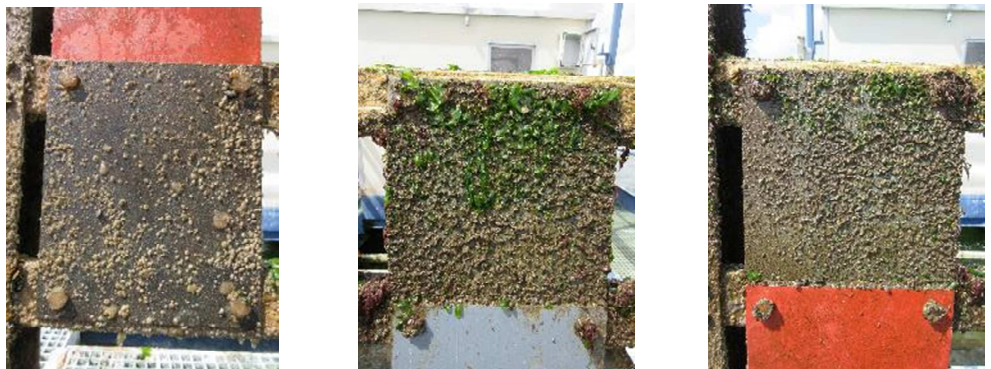
Figure 9. Detailed pictures of panels with Seajet ex3, GPN and blank PVC (from left to right).

For comparison the fouling condition of one of the blank PVC panels (top row left) is also shown in Figure 9. Here similar number of adult barnacles are found as on the other two products.

Chugoku as supplier of product Seajet ex3 has further investigated the results of this product and found out that on both panels the topcoat was not the self-polishing coating layer as it should have been. Apparently the wrong topcoat was applied here being the reason for the bad performance of both panels.

Two paint systems, e.g. Green Power Nano and Seajet ex3 have failed to demonstrate any antifouling effect in this raft test. Investigation by Chugoku revealed that the failure of product Seajet ex3 could be attributed to a mistake made during application of the test panels for this raft test.

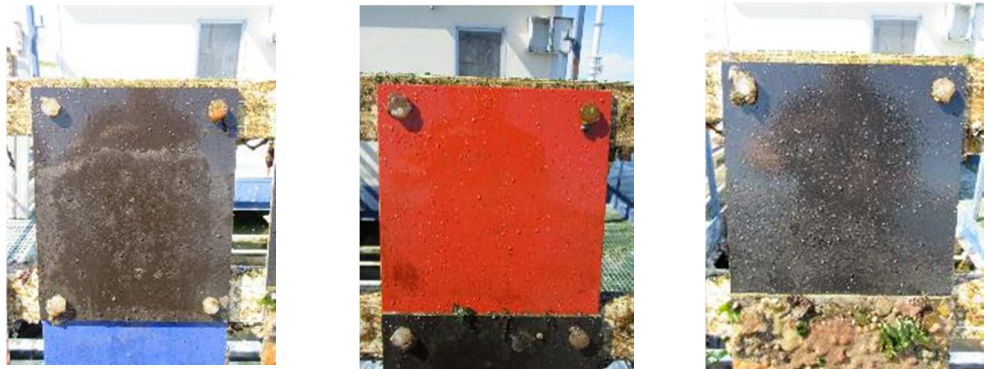
Figure 11. Detailed pictures of panels with Renolit, Silic One and Bioclean (from left to right).

The systems Silic One, Renolit Dolphin S, Bioclean and both types of MacGlide™ foils, all of these products are based on silicon containing top layers, only have thin slime fouling in variable degree (see Figure 11). Panels with Melkfett are also almost clean, only small parts of the panel surface were covered with thin slime. On both panels colonial tunicates were found growing around the edge of the panel (see Figure 12). These organisms are

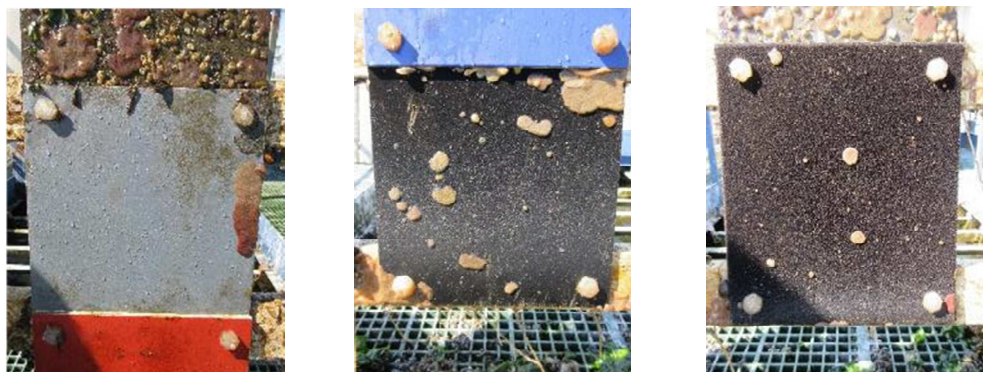
Figure 12. Detailed pictures of panels with Melkfett, Finsulate short and Finsulate long (from left to right).

neglected in the evaluation because they have not settled on the Melkfett surface but rather at the untreated back side of the panel. The panels with Finsulate showed start of growth of mainly colonial tunicates on both the short and long version (Figure 12).

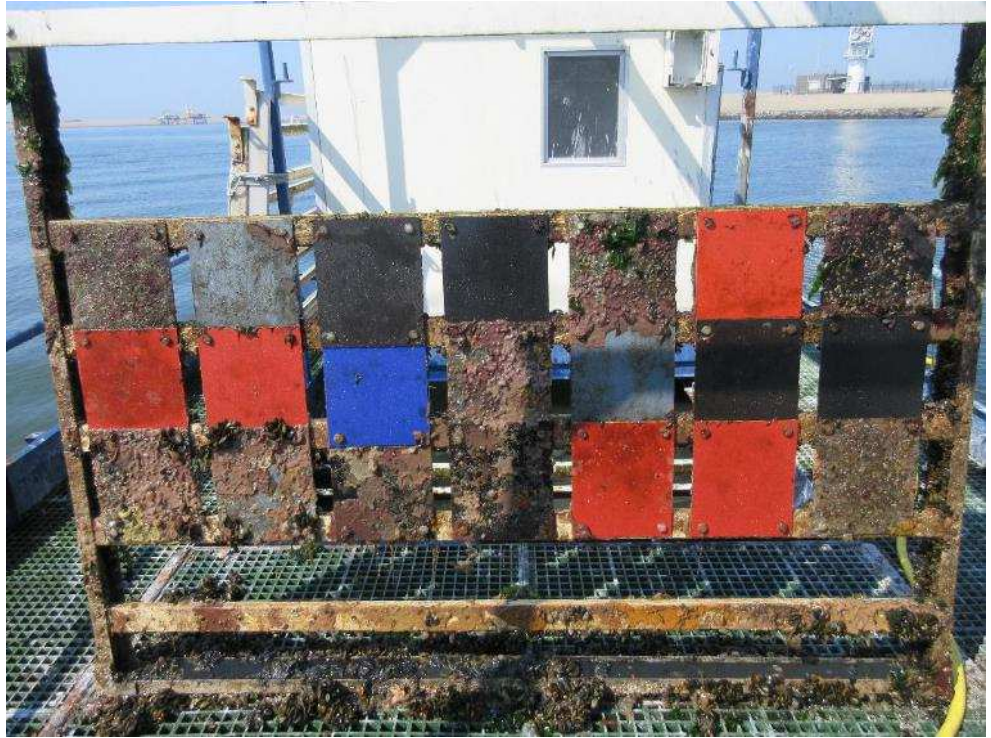
Figure 13. Panels with antifouling products at third inspection on August 26, 2019.

One month later at the next inspection the general picture on panel performance has not changed so much (see Figure 13). Overall the silicon based systems still show good efficacy against macro-fouling although some minor differences are starting to appear. For instance panels with MacGlide™ Pyramidal foil are doing better than panels with MacGlide™ foil: on the latter start of growth of some encrusting bryozoans can be seen (see Figure 14).

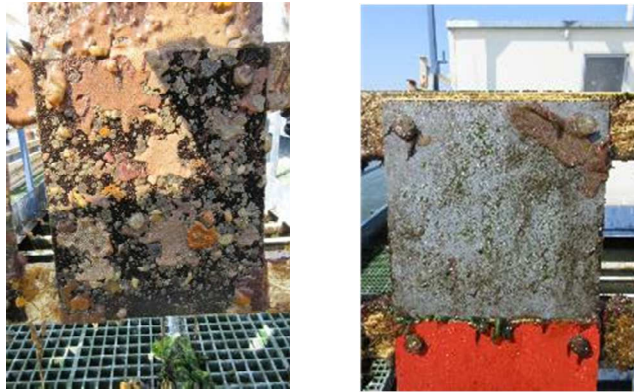
Figure 15. Detailed pictures of panels with Finsulate long (left) and Melkfett (right).

One of the Finsulate panels is shown in Figure 15. Striking observation is that underneath the tunicates no barnacles are found in contrast to the fouling observed on panels with non-effective systems and blank PVC where the barnacles are very abundant.

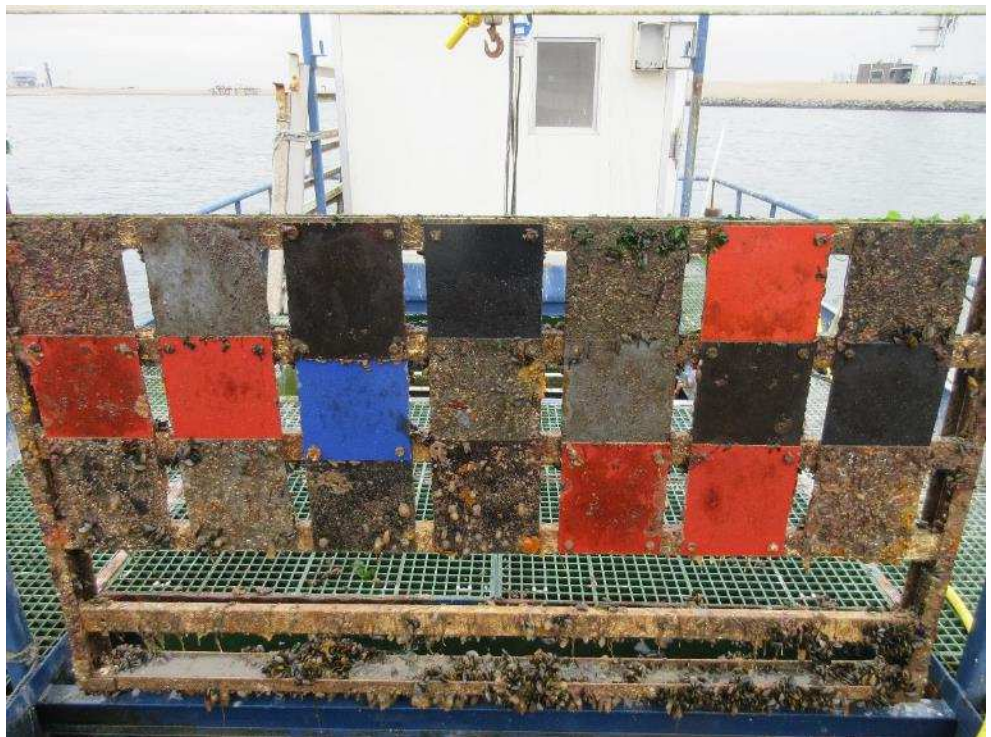
Figure 16. Panels with antifouling products at fourth inspection on September 24, 2019.

On September 24, 2019 the final raft inspection was carried out. Figure 16 gives an overview picture of the entire rack with panels. The performance of the separate products is described below and additionally shown in more detailed pictures.

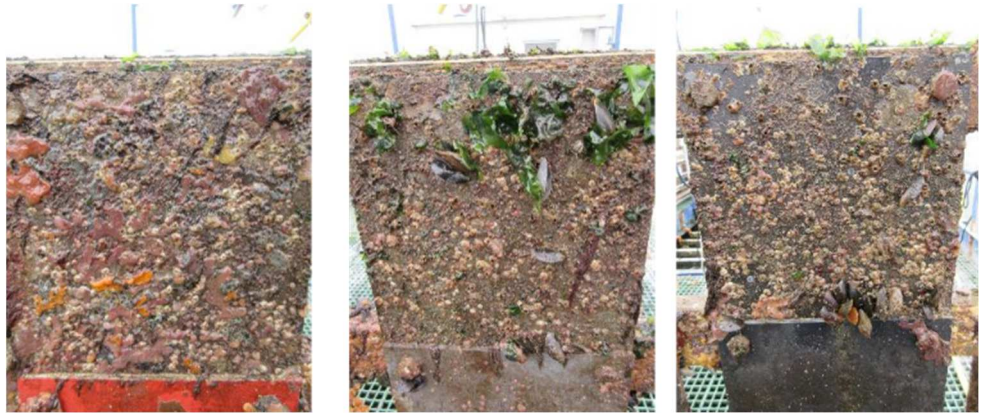
Figure 17. Detailed pictures of panels with PVC, GPN and Seajet ex3 (from left to right).

Similar fouling patterns were found on panels with products GPN and Seajet ex3.

Clear pictures of such fouling patterns are given in Figure 17 with one panel of each of these products.

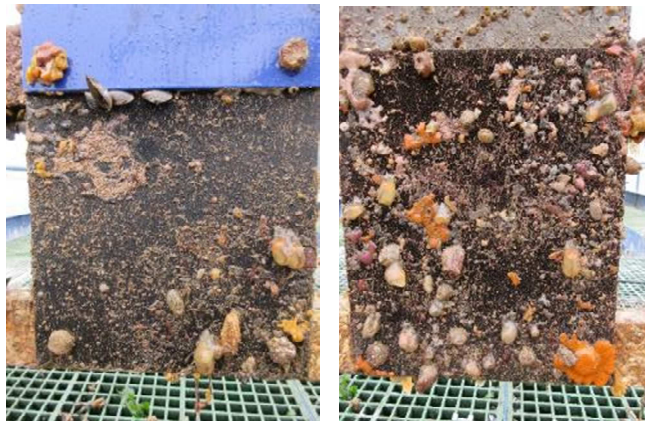
Figure 18. Detailed pictures of panels with Finsulate short (left) and Finsulate long (right).

The panels with Finsulate foils also show substantial coverage with macro-fouling, especially colonial tunicates on 40 - 50 % of the surface and 20 % hydroids. Next to this also single adult tunicates (*Ciona*) were found (see Figure 18).

But an important difference with the PVC and other panels mentioned above is that the Finsulate panels do not contain any barnacles.

The product Finsulate was tested in two versions in the raft test, one panel with short fibres and one panel with long fibres. Both panels showed relatively rapid fouling development during the season with a variety of macro-fouling organisms but dominated by colonial tunicates. In contrast to the blank PVC panels on which high numbers of adult barnacles were found, the panels with Finsulate did not show any barnacle fouling at any time during the season.

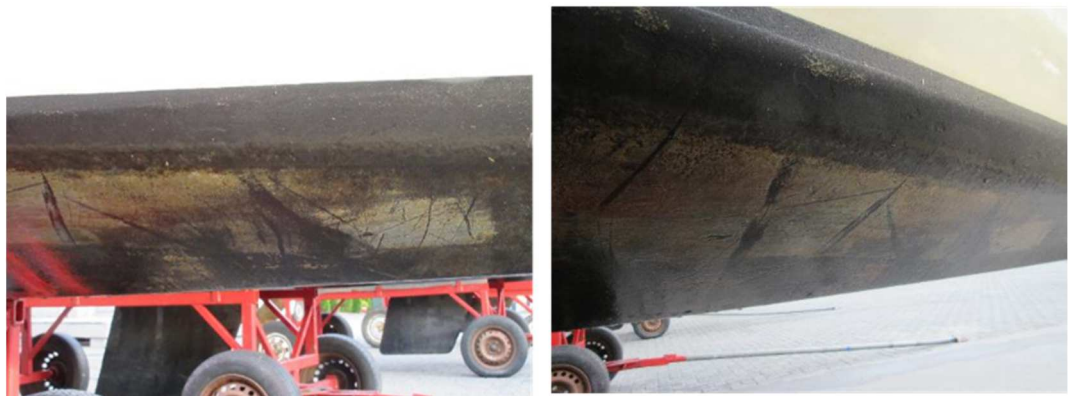
Figure 22. Boat with Melkfett product at the final inspection.

The hull of this boat has only limited slime fouling at the waterline; the fatty product shows patchy distribution and partial brownish or bluish discoloration (Figure 22).

The product Melkfett remains present on large part of the hull for the entire season. At the waterline, however, it is mainly gone and there some more slime fouling is usually found. Cleaning by hand was not attempted, that could have removed the fat layer.

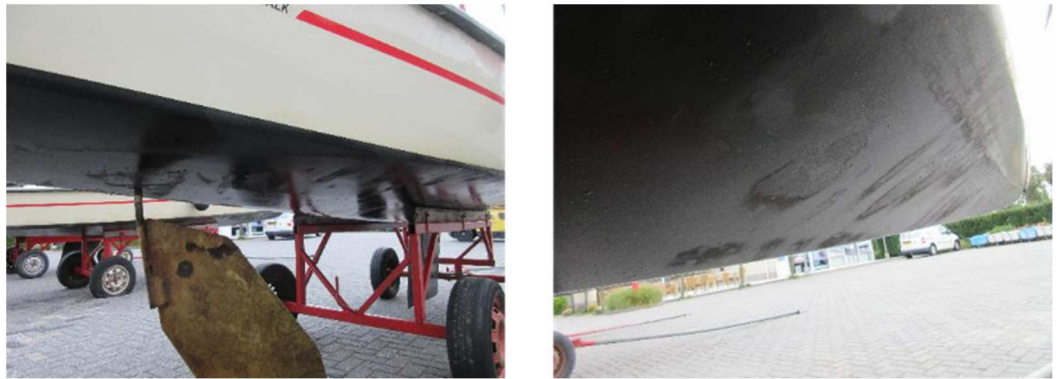
Figure 23. Boat with Bioclean product at the final inspection.

Except for thin slime along the waterline, the hull of this boat was largely free from fouling. The right picture in Figure 23 shows a few spots on the hull where the coating had partially detached as reported in the first inspection on July 4, 2019. Nevertheless, no other fouling than slime was present.

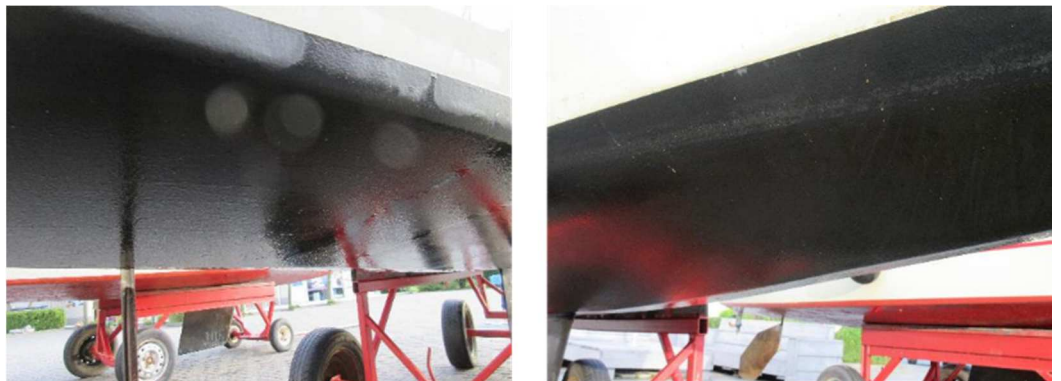
Figure 24. Boat with Seajet ex3 product at the final inspection.

This (self-polishing) product has kept the hull of the boat almost free from fouling except for some slime patches at the waterline. In the left picture in Figure 24 it can be seen that the coating shows some roughness, probably caused by the small blisters that were detected during the first inspection of this boat.

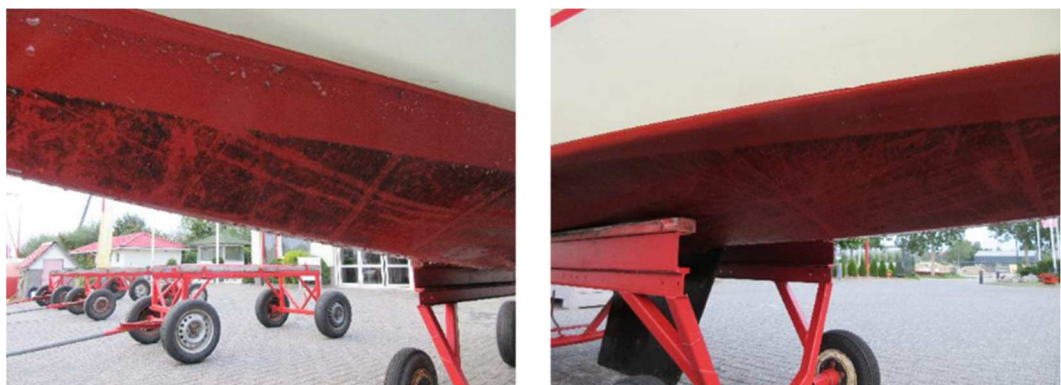
Figure 25. Boat with MacGlide™ Pyramidal foil at the final inspection.

Both pictures in Figure 25 clearly show the presence of a slime layer at a large part of the hull. Due to the red colour of the product this dark slime layer obviously can be seen much easier than on the black products on the other boats. As mentioned in Table 2, the slime can easily be wiped off by hand as long as the hull is wet. In dry condition the slime layer is more difficult to remove.

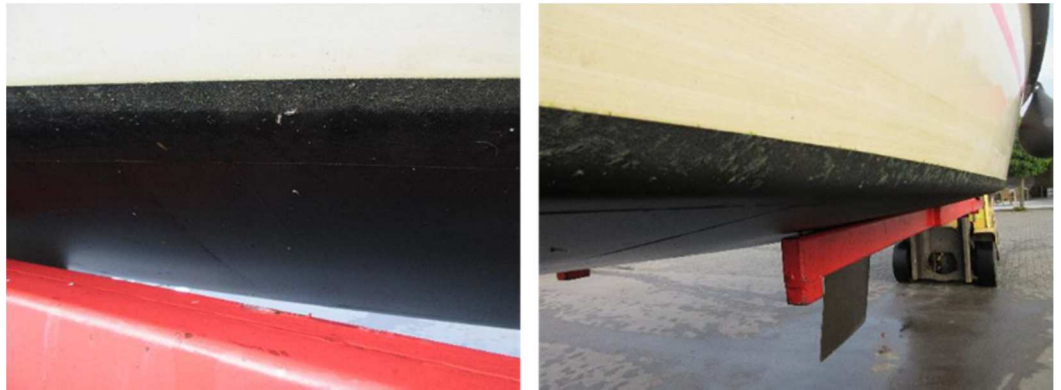
Figure 26. Boat with Finsulate product at the final inspection.

This boat was only inspected twice because at first inspection it was not yet available. Figure 26 shows that the underwater hull of this boat is free from fouling; the only area where fouling is present, is the waterline where relatively short algal filaments were found that had settled between the fibres of the Finsulate product. At the time of inspection the algal threads were shorter than 1 cm but they may grow larger with longer exposure times.

On the Finsulate product tested here also short and thin green algal filaments were found at the waterline.

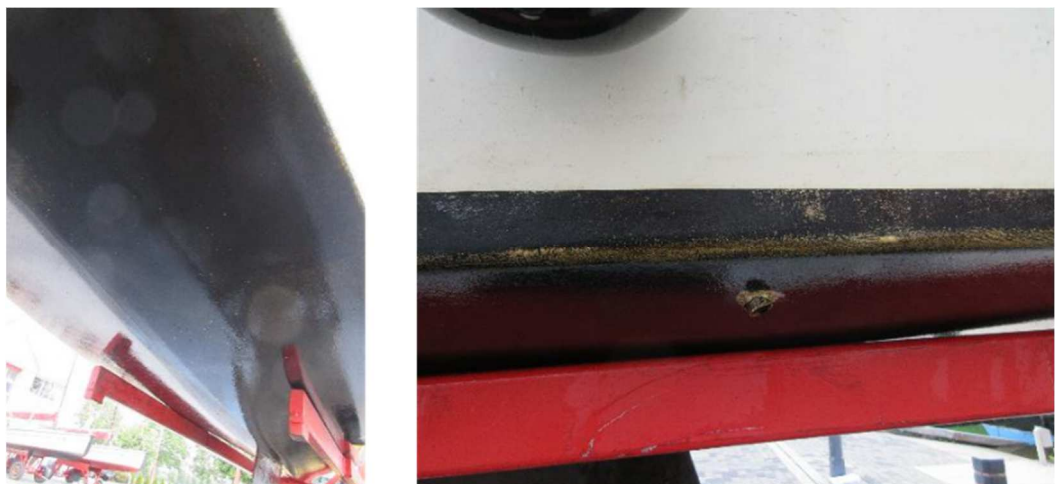
Figure 27. Boat with reference product at the final inspection.

The hull condition of these boats (two different boats were inspected on August 15 and September 24) is good; except for some slime patches along the waterline hardly any fouling was present (see Figure 27).

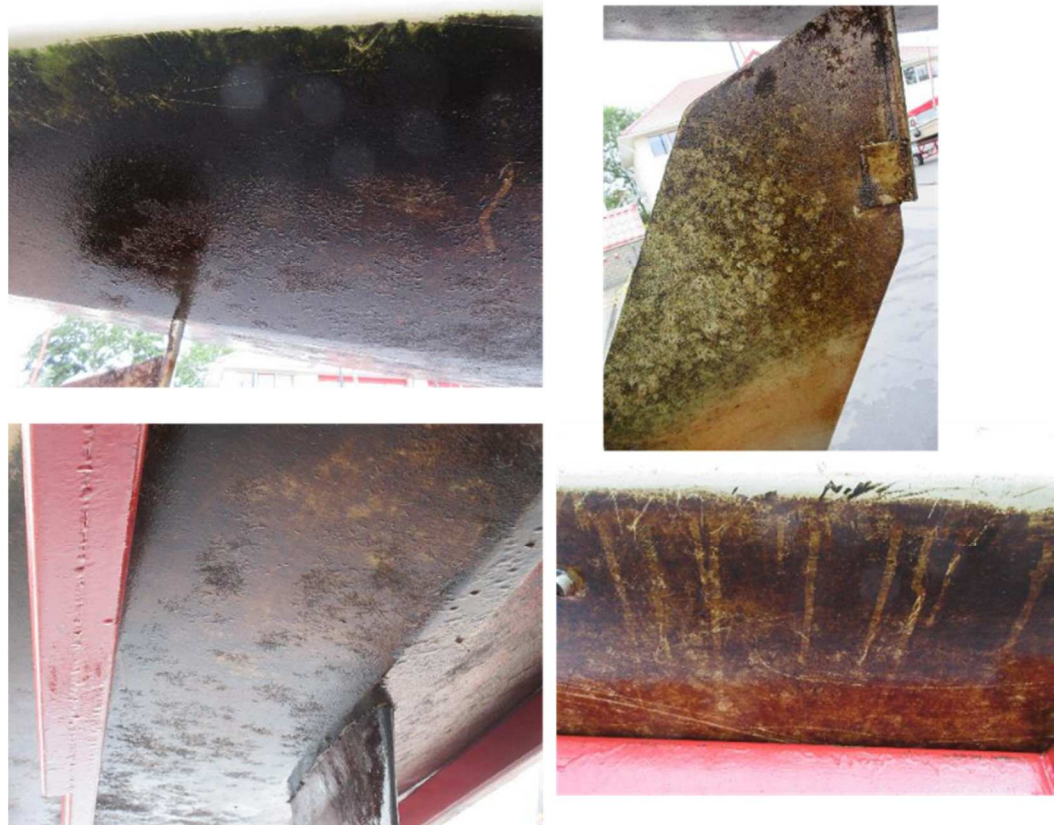
Figure 28. Compilation of pictures of the hull condition of a boat without antifouling at the fresh water location in Heeg.

The pictures shown in Figure 28 clearly indicate that a boat without antifouling product on the hull suffers from substantial fouling development. At start of the season the boats were clean. In the course of the year a brown and green slime layer builds up to a thickness of one or more millimetres and therein colonies of hydroids or algal organisms may develop. In one such colony a few small fresh water mussels were also found.

From these pictures it can be concluded that doing nothing against fouling at (this) fresh water location is not a good option. This boat should have been cleaned during the season with the brush installation Ottenhome has available.

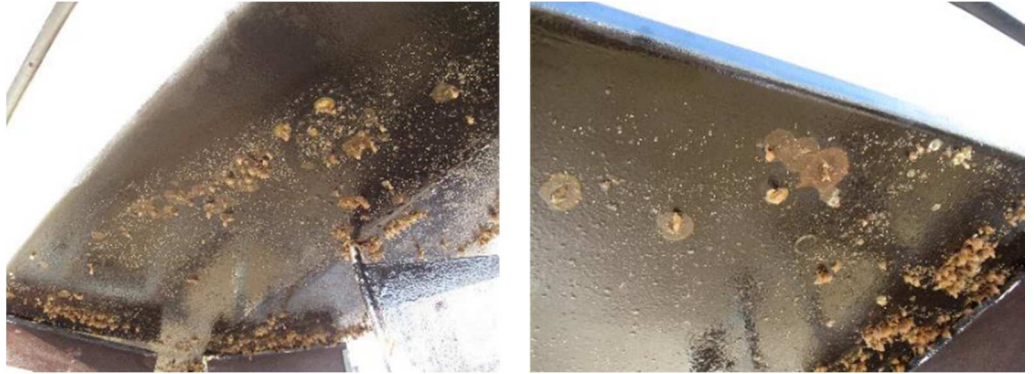
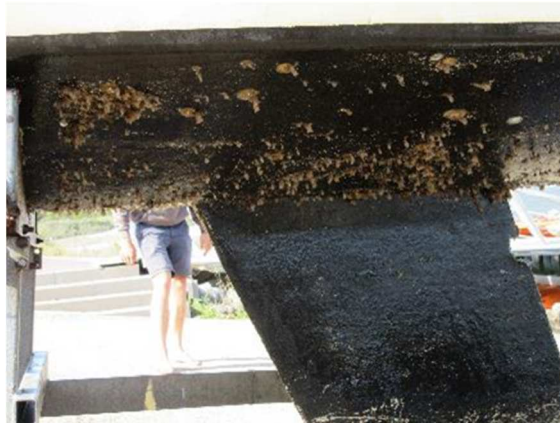
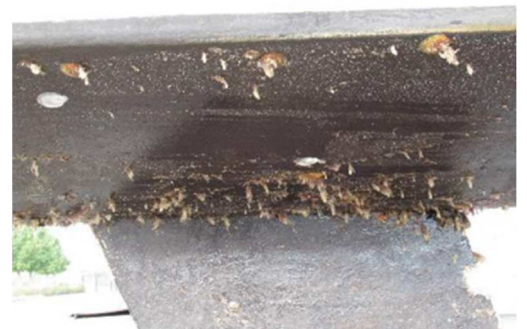
From the beginning quite strong settlement of young tubeworms (*Spirorbis*) and hydroids. Later on further growth of hydroids, encrusting bryozoans took place and also *Monia* shells with diameter up to 5 cm were found.

Most fouling did not adhere very strong but *Monia* shells were difficult to remove by hand. At the end of the season approx. 35 % hull coverage with macro-fouling, but neither barnacles nor algae were found on this paint. Easy cleaning except for the shells.

The silicon based products (Renolit Dolphin S foil and Silic One) showed almost similar performance: both were susceptible early in the season to settlement of young *Spirorbis* (small tubeworms) and later on in the season they were not able to prevent settlement of larger organisms such as bryozoans, hydroids and *Monia* shells. On both boats between 35 – 45 % of the hull was covered with such macro-fouling. Green algae were not found on both boats. Cleaning the hull by hand was relatively easy except for the (flat) *Monia* shells that were able to adhere quite strong.

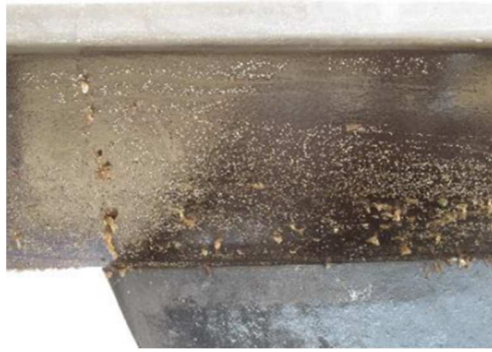
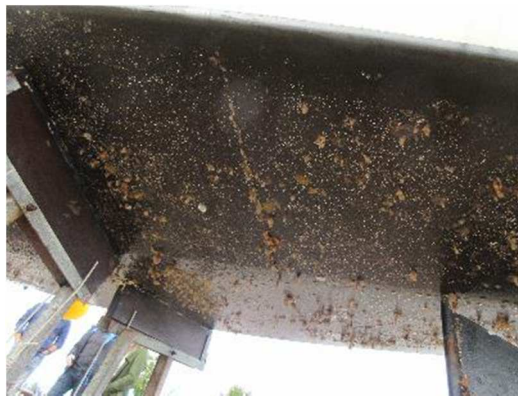
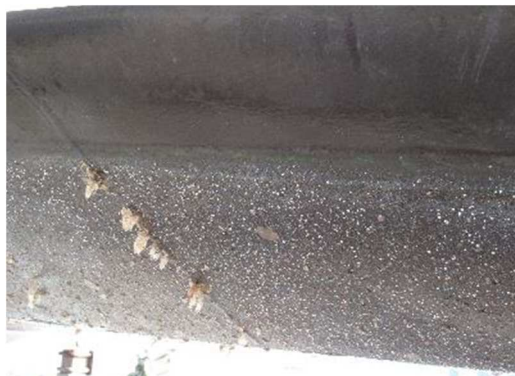
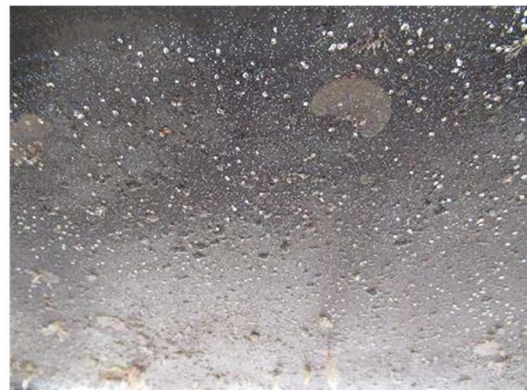
Renolit Dolphin S

Early on in the season quite strong settlement of young *Spirorbis*, hydroids and bryozoans. During the season further growth of these groups of organisms and from August onwards also *Monia* shells of 3-5 cm diameter. Except for the *Monia* shells fouling could easily be removed by hand or water wash. Also on this product neither barnacles nor green algae were found.

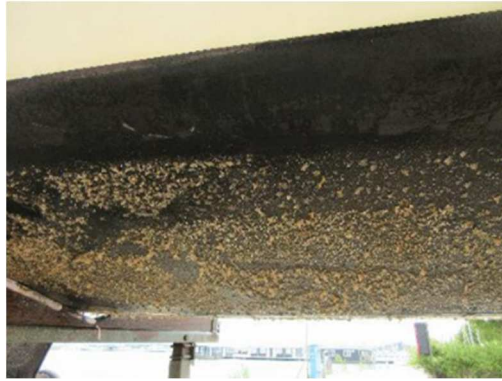
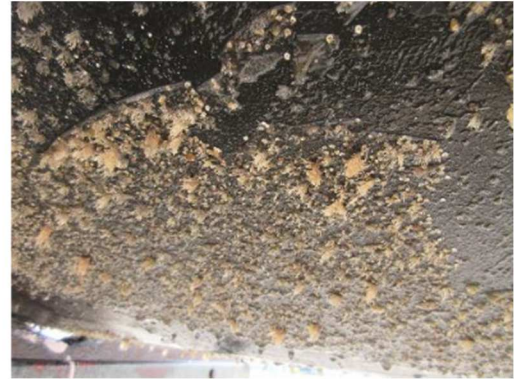
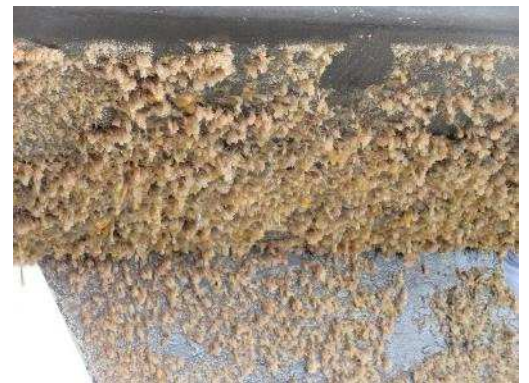
### Bioclean

This product failed early in the season due to a mistake at application of the paint. After two inspections, the boat owner decided to remove the Bioclean product and replaced it by the reference paint. This boat was not further inspected.

Because of the application failure this boat gave a perfect impression of the strong fouling conditions present at this location early in the season. The location Bruinisse belongs to the lake Grevelingen in the province of Zeeland, a lake generally known for a bad water quality with very low oxygen content.

The boat initially provided with the product Bioclean, which failed because of a mistake during application, clearly indicates that the fouling pressure at this location is much higher and much more diverse than at the fresh water location.

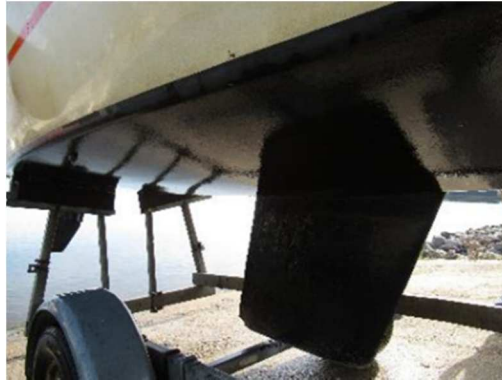
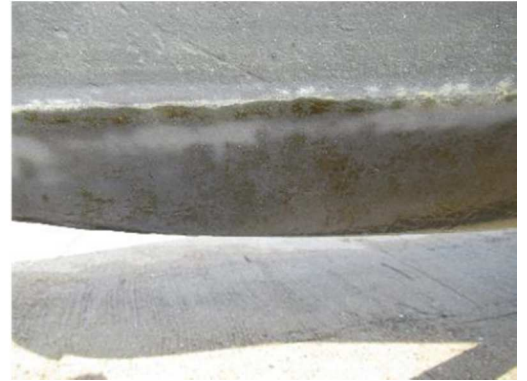
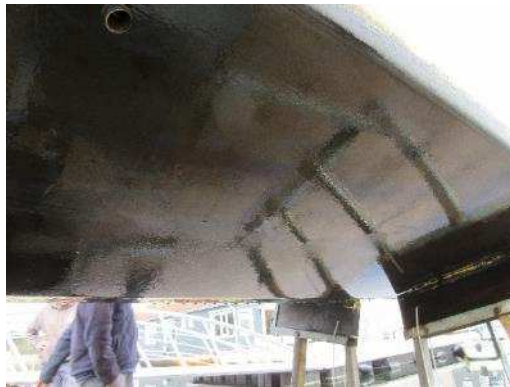
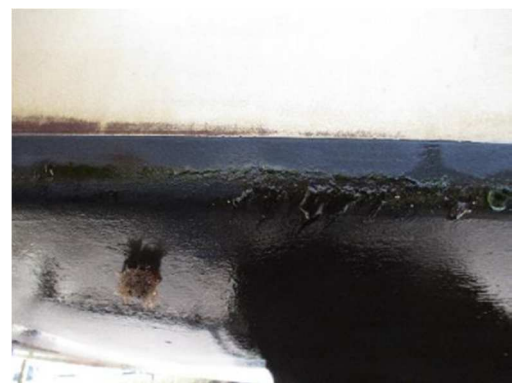
The hull of the boat with this product remains free from fouling almost the entire season. Slime fouling was little and very thin until the final inspection in October where some thicker slime was found around the waterline on the aft part of the boat (see picture far right, October 25). This paint has strong polishing properties. Cleaning of this paint should not be done; that would give even stronger polishing and most likely a shorter lifetime.

The new product Seajet ex3, also from Chugoku, gave better performance at all inspections. Here only slime fouling was found, in the beginning very thin and slightly thicker at the end of the season.

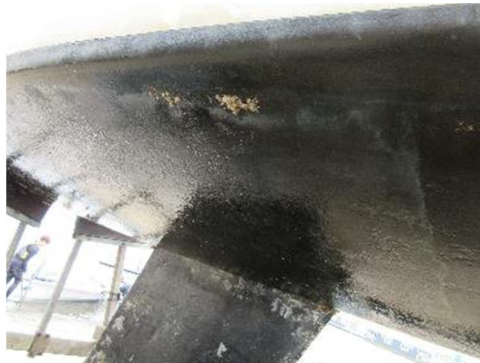
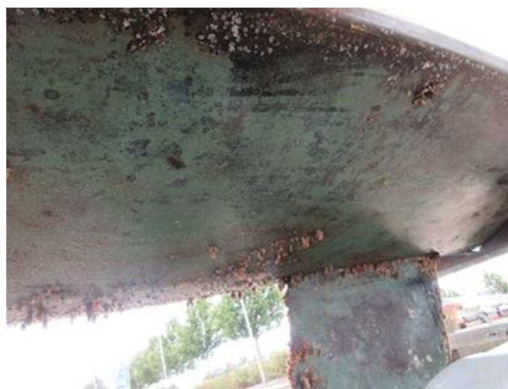
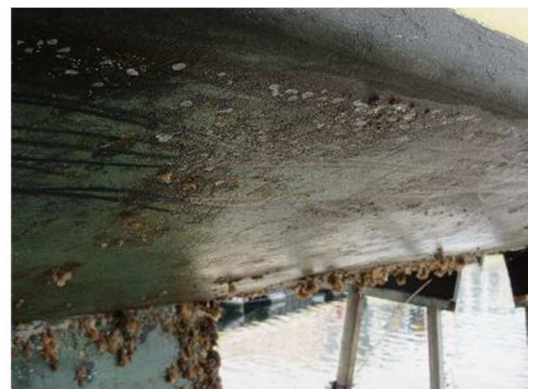
At first inspection large numbers of hydroids, *Spirorbis* and tunicates were found in the fat layer. At second inspection approx. 15 % of hull was covered with hydroids, *Spirorbis* and few barnacles. The fatty product was quite patchy distributed on the hull and showed bluish discoloration. At the end of the season around 20 % of the hull surface was covered with macro-fouling, with especially on the aft part barnacles and hydroids on top of this (see picture at the bottom of this page). Cleaning of the hull was not attempted, would have removed larger parts of the fat layer.

The product Melkfett showed on the one hand quite rapidly initial fouling of especially *Spirorbis* and hydroids. From the second inspection onwards, however, the estimated coverage with fouling did not increase very much up to the last two inspections when, on the aft part of the boat, an increasing number of adult barnacles was found. The fat remained clearly visible on a large part of the underwater hull and showed bluish discoloration. Cleaning of the hull was not attempted.

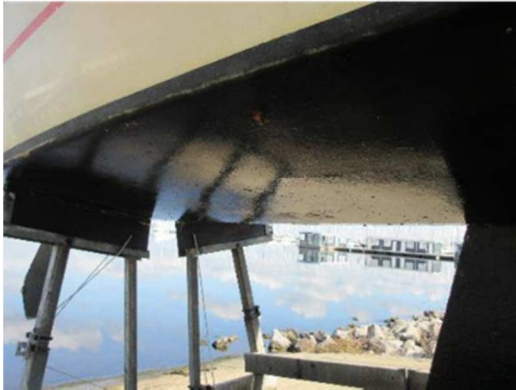
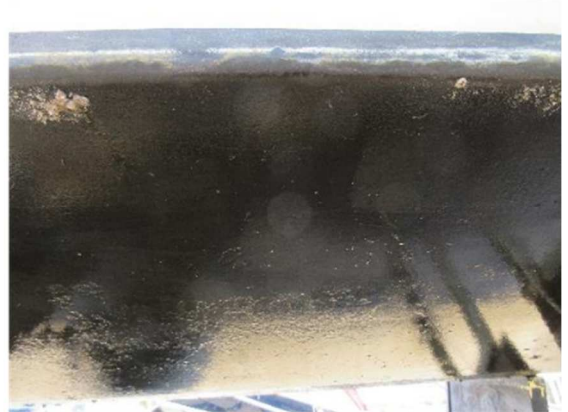
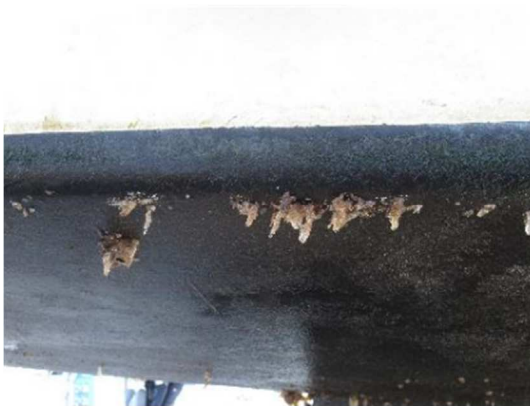
On the aft part of the boat around 10% was covered with barnacles with hydroids on top of them and here also green algae and some *Spirorbis* were found. Cleaning of this erodible paint should not be done, will probably reduce the effective lifetime and cause higher release of paint components in the water.

The reference paint Seajet 023 gave a good efficacy up to halfway the season. At the inspections in September and October, however, the performance went down mainly because of increasing growth of thin grey hydroid (same as found on the two yachts with ultrasound) and barnacles that were able to settle on the aft part and at the waterline. Cleaning is not an option for this paint.

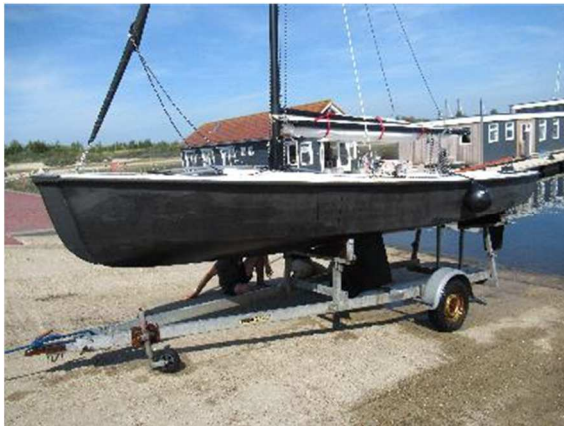
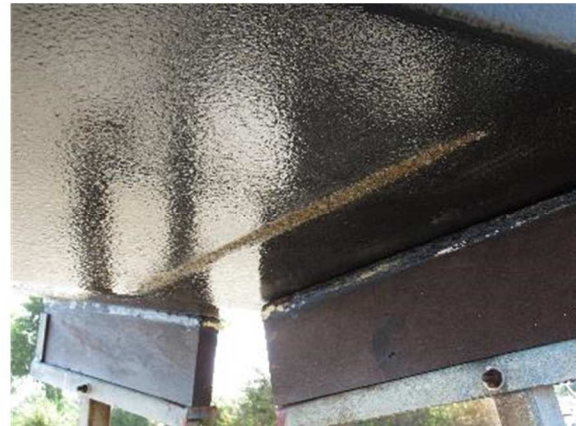
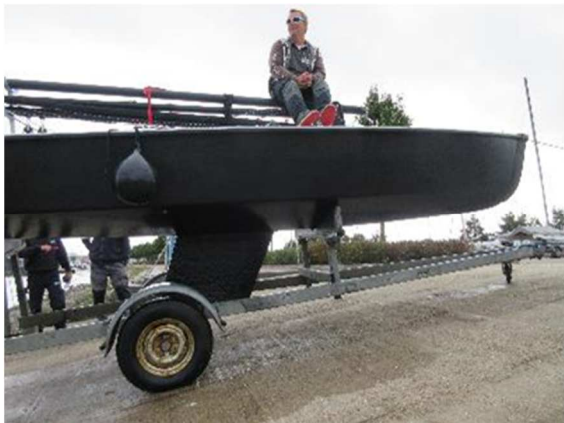
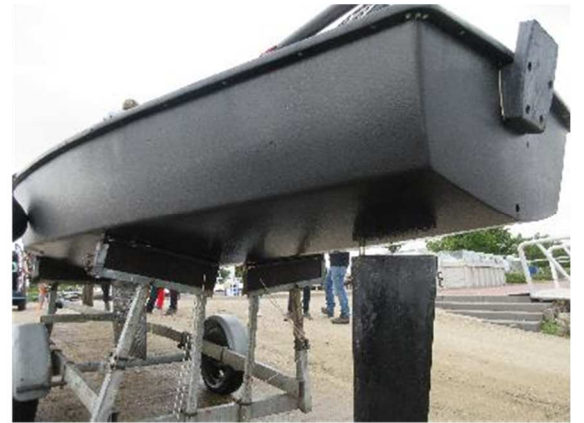
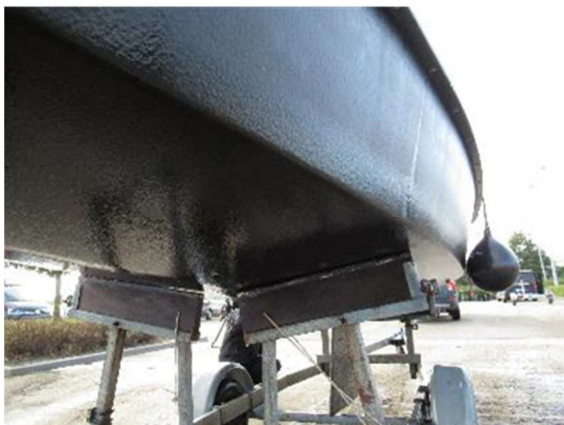
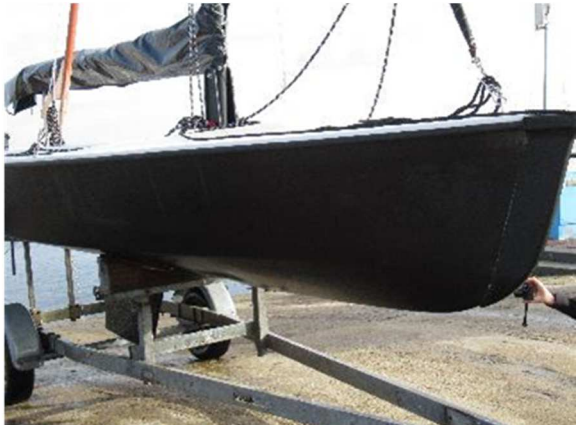
The boat with this product was inspected four times. Prior to each inspection the boat had been cleaned outside the water by the owner. At each inspection the hull of the boat was perfectly clean but the fouling condition prior to cleaning was never seen.

Picture at the right taken at August 23 shows a small spot where fouling was not fully removed. Here remains' of *Spirorbis*, some barnacles and small hydroids were found.

The necessity for cleaning, as stated by the supplier, allows the assumption to make that the Ecospeed coating does not have a(ny) preventive effect, so large part of the hull will be covered with fouling. Being absent during cleaning of the boat Endures also has not been able to give a judgement on ease of cleaning.

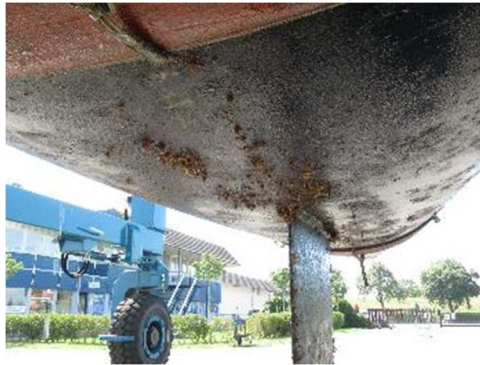
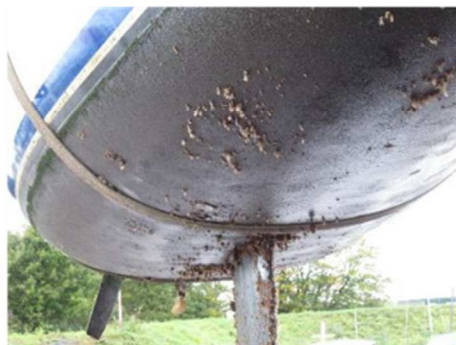
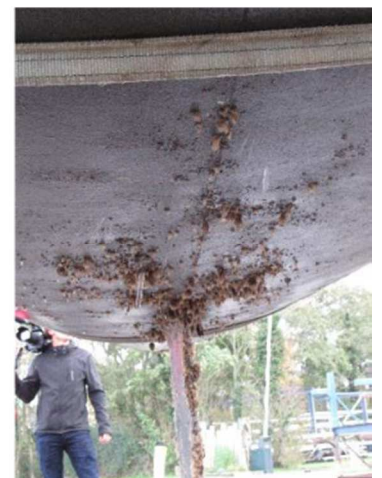
### Shipsonic

In the beginning the hull was entirely clean, about half way of the season some local spots with barnacles and a green algal beard at the waterline (see picture August 23) were found.

Later on (September 19) thick slime fouling was present at the waterline and the transducer was found to be switched off. At the end of the season about 50 % of the underwater hull was covered with thin grey hydroid (relatively easy to wipe away by hand) and local spots of barnacles were found with estimated coverage of 15 %. Barnacles and algae were not so easy to remove by hand.

The two ultrasonic systems showed slightly different performance with Sonihull (two transducers, one on each side) a little bit better in the second half of the season, but it cannot be excluded that Shipsonic (only 1 transducer) performed less because this transducer was found to be switched off for some time between the third and fourth inspection.

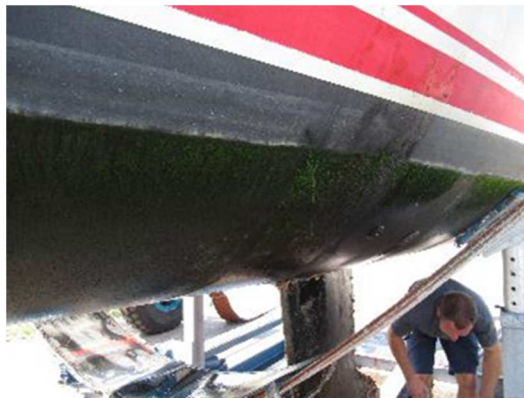
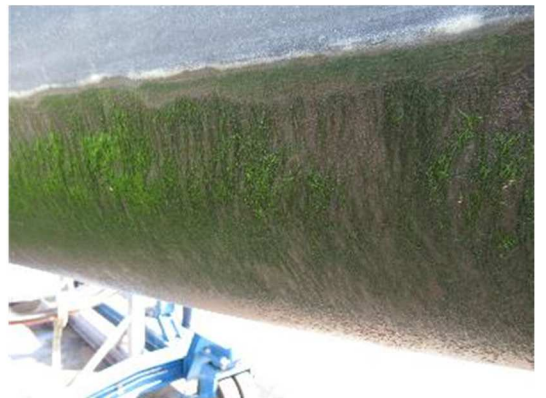
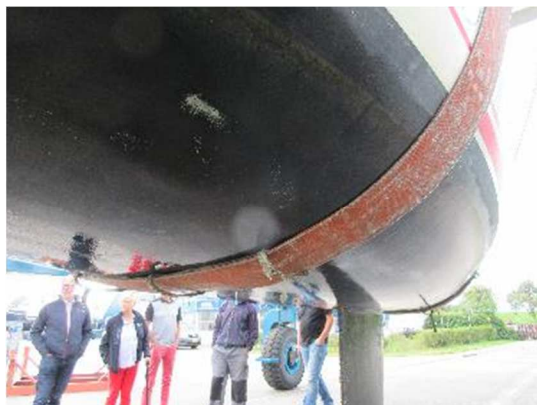
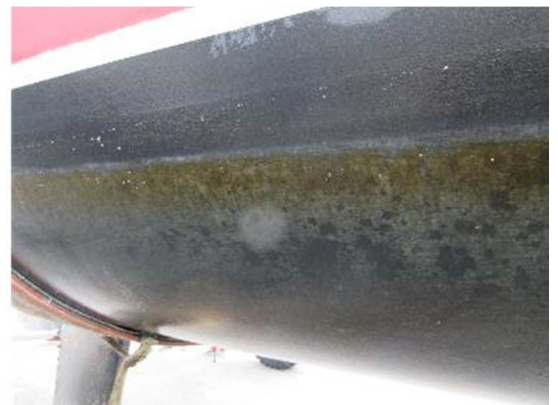
Sonihull (Lamers System Care)

In the beginning the hull was entirely clean, later on in August a strong beard of green algae had developed along the waterline. Because of a broken strut that needed repair, the boat stayed out of the water for about a week.

In September dark slime was present and the algal beard was less prominent. At the end of the season the boat was (still) free from hard fouling but about 10 % of the hull was covered with thin grey hydroid and next to this green algal filaments (10 – 15 cm long) were present at parts along the waterline. The soft grey hydroid was relatively easy to wipe away by hand.

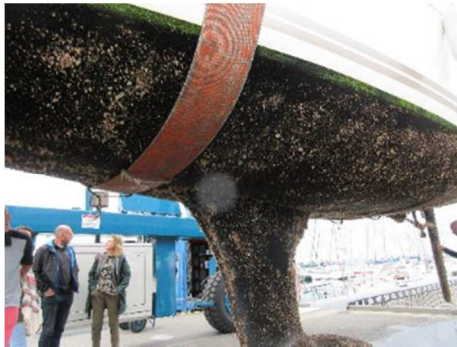
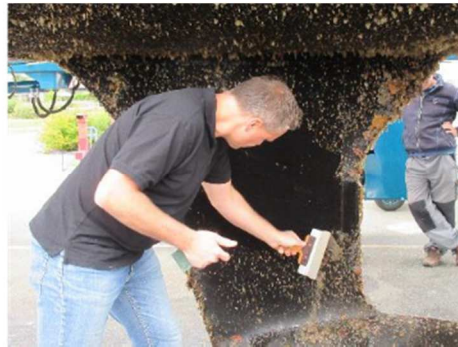
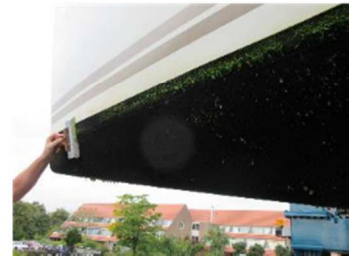
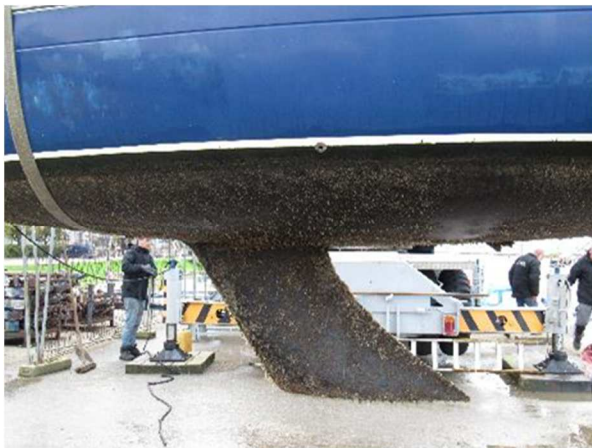
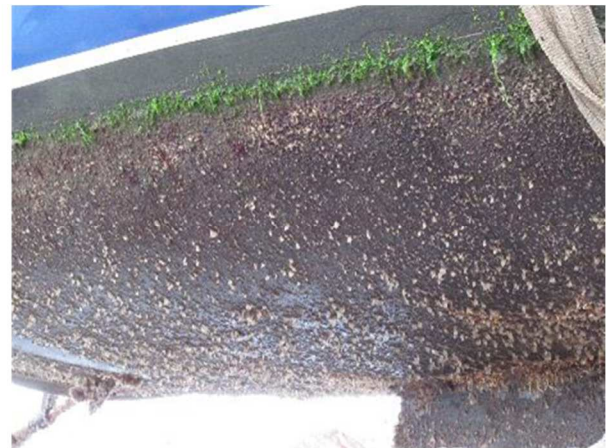
Both yachts showed severe fouling of mainly (colonial) tunicates and hydroids. Next to this green algae were found along the waterline.

Large part of this fouling could be wiped off relatively easily with a spatula (see pictures of September 19). On both boats no barnacles were found.
