**MARINE ACCIDENT
INVESTIGATION BRANCH**

SAFETY DIGEST

**Lessons from Marine
Accident Reports
1/2018**

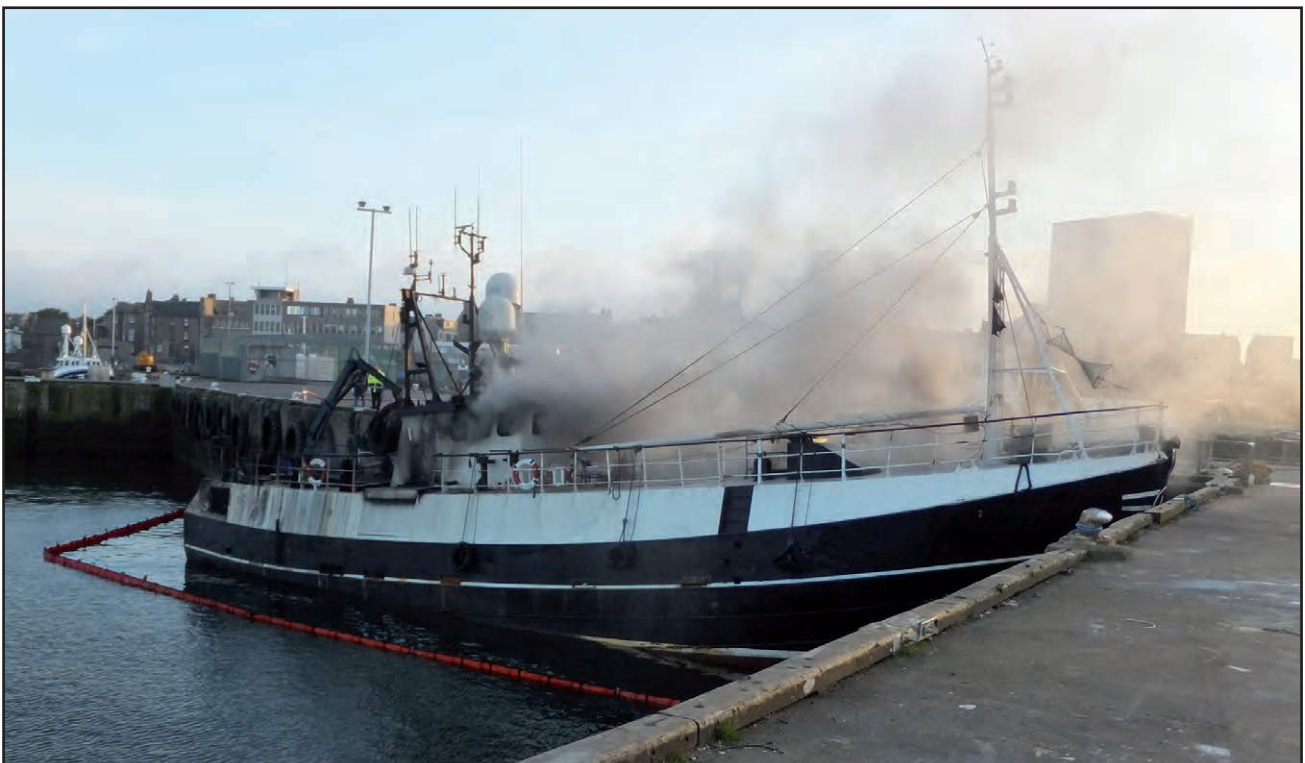
At 0537, with flames emitting from the vessel, the crew of another fishing vessel secured nearby called the emergency services. At 0546, the first fire appliance was on scene and the fire service continued to tackle the blaze until the following day (Figure 1). By this time, the vessel was extensively damaged and it was later declared a constructive total loss.

Figure 1: The fishing vessel on fire

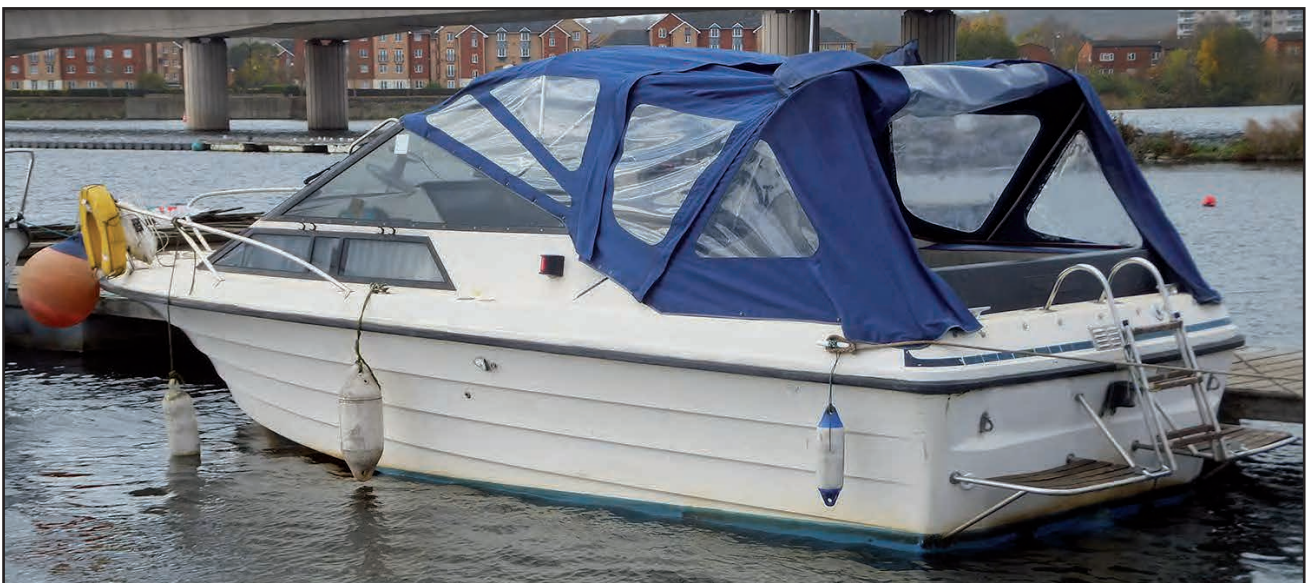
Figure 1: The motor cruiser
